# Access Compliance Report

## Public Rights-of-Way

### (Curb Ramps)

Intersection ID: 45242	Main Street: TALUS_TRACE_LN	Cross Street: KODIAK_CT	Location: NE
ADA ID: 72193802C64E	Ramp Type: Perp	Initial Pass/Fail: Pass	Overall Compliance: No
Severity Score: 5			
Codes/Mitigation Info/Possible Solution		Field Measurements/Component Compliance

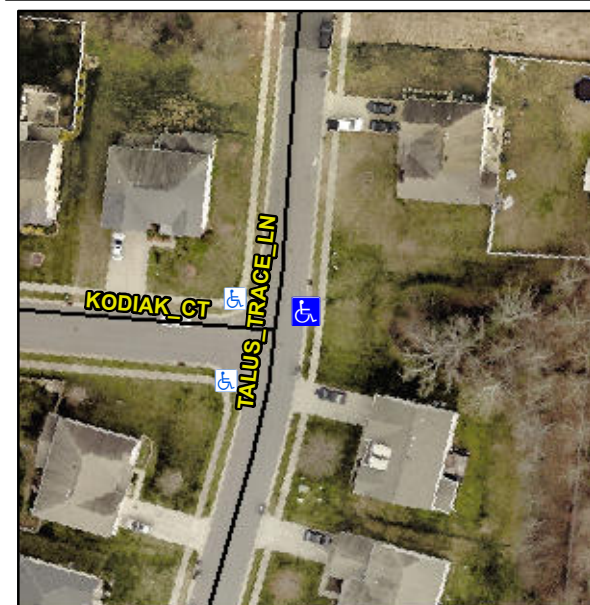
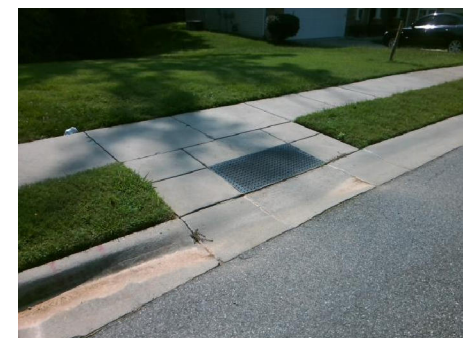
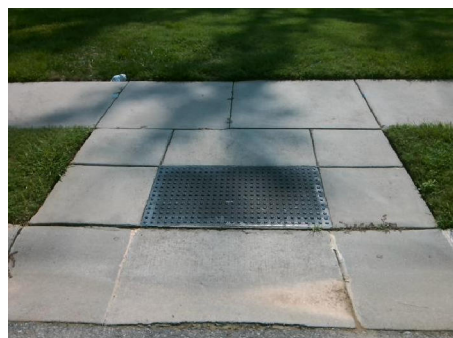
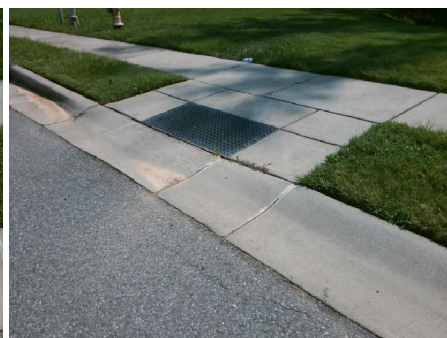
**Not Found, R304.2.1, R302.7,  
R304.5.4**

Compliance	Description	Data	Compliance	Description	Data
N/A	Ramp Length (in)	47.5	Yes	Ramp Slope (%)	7.8
Yes	Ramp Width (in)	48.0	Yes	Ramp XSlope (%)	0.3
N/A	Flare Type LT	Sloped	N/A	Flare Type RT	N/A
N/A	Flare Slope LT (%)	7.1	N/A	Flare Slope RT (%)	1.9
N/A	Flare Traversable LT?	No	N/A	Flare Traversable RT?	No
No	Landing Length (in)	47.0	Yes	DWS Provided?	Yes
Yes	Landing Width (in)	48.0	Yes	DWS Contrast?	Yes
Yes	Landing Slope (%)	1.2	Yes	DWS Length (in)	24.5
Yes	Landing X Slope (%)	1.8	Yes	DWS Full Width?	Yes
N/A	Landing Curb? (Y/N)	No	Yes	DWS Offset (in)	0.5
N/A	Shared Landing?	No			
No	Gutter Ponding?	Yes	No	Gutter Slope (%)	12.5
Yes	Gutter Lip Ht (in)	0.0	Yes	Gutter X Slope (%)	1.9
N/A	Painted X Walk1?	No	N/A	Painted X Walk2?	N/A
	X Walk 1 Direction	To W		X Walk 2 Direction	N/A
N/A	X Walk 1 Width (in)	N/A	N/A	X Walk 2 Width (in)	N/A
	X Walk 1 Slope (%)	1.8		X Walk 2 Slope (%)	N/A
	X Walk 1 X Slope (%)	1.6		X Walk 2 X Slope (%)	N/A

N/A	Ramp inside XWalk1?	N/A	N/A	Ramp inside XWalk2?	N/A
	Road Slope (%)	N/A	N/A	Clear Space?	Yes
	Road X Slope (%)	N/A	N/A	Clear Space to XWalk (in)	N/A
Yes	Any Obstructions?	No	Yes	Storm Grate/Utility Hazard?	No
	Obstruction Type			Storm Grate/Utility Type	
		N/A			N/A
			Yes	Surface Condition? (G/P)	Good

Possible Solutions:

**Remove & Replace Entire Ramp.  
Remove & Replace Gutter.**
