Access Compliance Report Public Rights-of-Way (Curb Ramps)

Intersection ID: 30000 Main Street: OAKBORO LN Cross Street: OLD CAROLINA DR Location: SW ADA ID: 721C3658C2BB Ramp Type: PerpDiag Initial Pass/Fail: Fail **Overall Compliance: No** Severity Score: 33.75

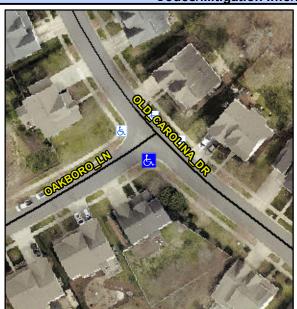
ricia measurements/component compnance					
Compliance Description		Data	Compliance Description		Data
N/A	Ramp Length (in)	70.0	Yes	Ramp Slope (%)	5.8
No	Ramp Width (in)	47.0	No	Ramp XSlope (%)	7.5
N/A	Flare Type LT	N/A	N/A	Flare Type RT	N/A
N/A	Flare Slope LT (%)	N/A	N/A	Flare Slope RT (%)	N/A
N/A	Flare Traversable LT?	N/A	N/A	Flare Traversable RT?	N/A
N/A	Landing Length (in)	N/A	N/A	DWS Provided?	N/A
N/A	Landing Width (in)	N/A	N/A	DWS Contrast?	N/A
N/A	Landing Slope (%)	N/A	N/A	DWS Length (in)	N/A
N/A	Landing X Slope (%)	N/A	N/A	DWS Full Width?	N/A
N/A	Landing Curb? (Y/N)	N/A	N/A	DWS Offset (in)	N/A
N/A	Shared Landing?	N/A			
N/A	Gutter Ponding?	N/A	N/A	Gutter Slope (%)	N/A
N/A	Gutter Lip Ht (in)	N/A	N/A	Gutter X Slope (%)	N/A
N/A	Painted X Walk1?	No	N/A	Painted X Walk2?	No
	X Walk 1 Direction	To E		X Walk 2 Direction	To N
N/A	X Walk 1 Width (in)	N/A	N/A	X Walk 2 Width (in)	N/A
	X Walk 1 Slope (%)	1.6		X Walk 2 Slope (%)	1.5

X Walk 1 X Slope (%)	1.7		X Walk 2 X Slope (%)	2.4
N/A	Ramp inside XWalk1?	N/A	N/A	Ramp inside XWalk2?	N/A
	Road Slope (%)	2.8	N/A	Clear Space?	N/A
	Road X Slope (%)	2.1	N/A	Clear Space to XWalk (in)	N/A
N/A	Any Obstructions?	N/A	N/A	Storm Grate/Utility Hazard?	N/A

Possible Solutions: Remove & Replace Curb Ramp With Two New Directional Ramps or Equivalent. Surveyor Notes: N/A PROW/ADA: Not Found, R304.5.1, R304.5.3
