# Access Compliance Report

## Public Rights-of-Way

### (Curb Ramps)

| Intersection ID: 43480 | Main Street: LIONESS_ST | Cross Street: ERWIN_RD | Location: NW |

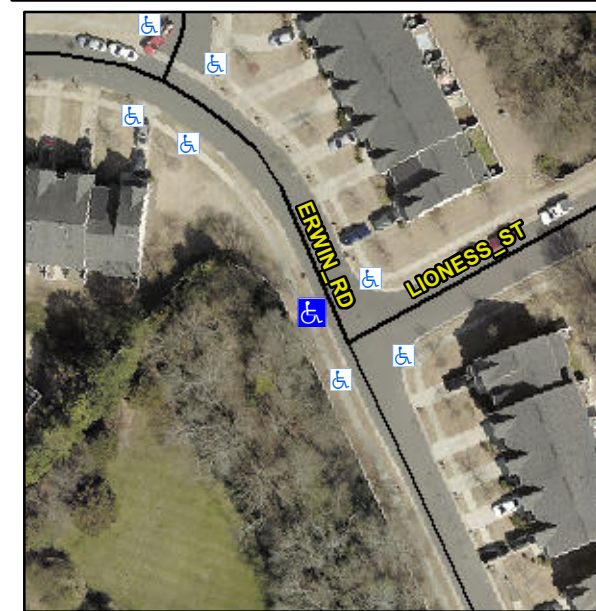
| ADA ID: 721E7F80B593 | Ramp Type: Perp | Initial Pass/Fail: Pass | Overall Compliance: No |
| Severity Score: 5 | | | |

**Not Found, R305.2, R304.5.4**

| Compliance | Description | Data | Compliance | Description | Data |
|---|---|---|---|---|---|
| N/A | Landing Curb? (Y/N) | No | No | DWS Offset (in) | 3.5 |
| Yes | Gutter Ponding? | No | No | Gutter Slope (%) | 13.0 |

**Remove & Replace Entire Ramp.  
Remove & Replace Gutter.**

Total Cost: \$ 2600.00
