Access Compliance Report

Public Rights-of-Way

(Curb Ramps)

Intersection ID: N/A	Main Street: SPEER_BV	Cross Street: MILLENNIUM_AV	Location: SW
ADA ID: 72298DDA8DEE	Ramp Type: Directional1	Initial Pass/Fail: Fail	Overall Compliance: No
Severity Score: 1.25			
Codes/Mitigation Info/Possible Solution		Field Measurements/Component Compliance

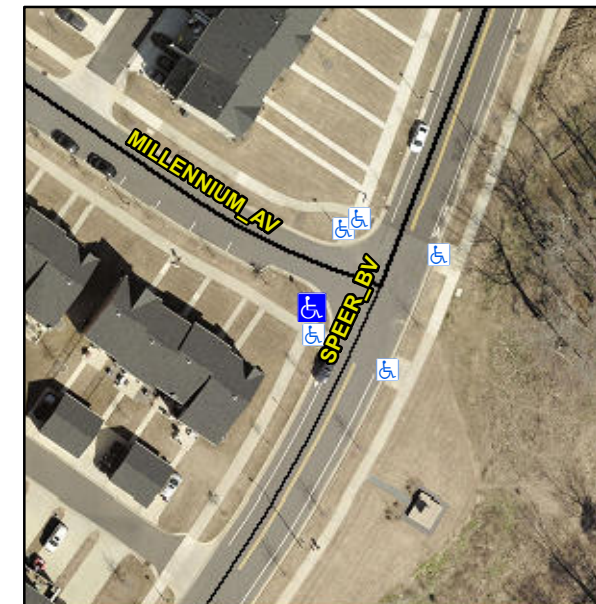
Compliance	Description	Data	Compliance	Description	Data
N/A	Ramp Length (in)	100.0	N/A	Grade Break?	N/A
Yes	Ramp Width (in)	67.0	N/A	Grade Break Slope (%)	0.0
Yes	Ramp Slope (%)	2.0	N/A	Grade Break XSlope (%)	0.0
No	Ramp XSlope (%)	2.7			
N/A	Flare Type LT	N/A	N/A	Flare Type RT	N/A
N/A	Flare Slope LT (%)	N/A	N/A	Flare Slope RT (%)	0.0
N/A	Flare Traversable LT?	N/A	N/A	Flare Traversable RT?	N/A
N/A	Landing Length (in)	0.0	N/A	DWS Provided?	N/A
N/A	Landing Width (in)	0.0	N/A	DWS Contrast?	N/A
N/A	Landing Slope (%)	0.0	N/A	DWS Length (in)	N/A
N/A	Landing X Slope (%)	0.0	N/A	DWS Full Width?	N/A
N/A	Landing Curb? (Y/N)	N/A	N/A	DWS Offset LT (in)	N/A
N/A	Shared Landing?	N/A	N/A	DWS Offset RT (in)	N/A
N/A	Gutter Ponding?	0.0	N/A	Gutter Slope (%)	N/A
N/A	Gutter Lip Ht (in)	0.0	N/A	Gutter X Slope (%)	N/A
N/A	Painted X Walk1?	No		Road Slope (%)	2.5
	X Walk 1 Direction	To N		Road X Slope (%)	1.6
	X Walk 1 Width (in)	N/A		Clear Space?	N/A

X Walk 1 Slope (%)	2.5	N/A	Clear Space to XWalk (in)	N/A
	X Walk 1 X Slope (%)	1.6	N/A	Storm Grate/Utility Hazard?	N/A
N/A	Ramp inside XWalk1?	N/A		Storm Grate/Utility Type	
N/A	Any Obstructions?	N/A			N/A
	Obstruction Type		Yes	Surface Condition? (G/P)	Good
			N/A	Curb Slope (%)	0.6

Possible Solutions:

Remove & Replace Entire Ramp.

R304.5.3

Total Cost:

\$ 1600.00
