Access Compliance Report

Public Rights-of-Way

(Curb Ramps)

Intersection ID: 3612	Main Street: BRIDLE_RIDGE_LN	Cross Street: FURLONG_TL	Location: SE
ADA ID: 72421821D586	Ramp Type: Perp	Initial Pass/Fail: Fail	Overall Compliance: No
		Severity Score: 10

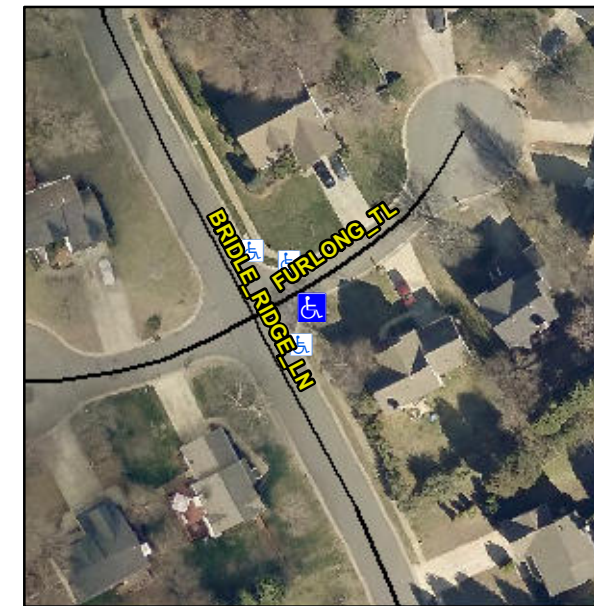
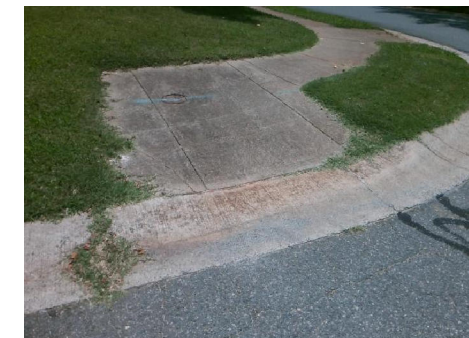
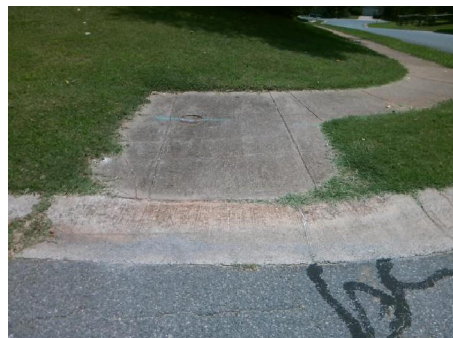
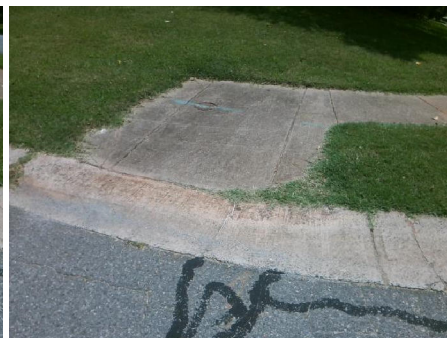
Not Found, R304.5.1, R304.5.3

Compliance	Description	Data	Compliance	Description	Data
N/A	Ramp Length (in)	53.0	Yes	Ramp Slope (%)	7.3
No	Ramp Width (in)	47.0	No	Ramp XSlope (%)	2.1
N/A	Flare Type LT	N/A	N/A	Flare Type RT	N/A
N/A	Flare Slope LT (%)	N/A	N/A	Flare Slope RT (%)	N/A
N/A	Flare Traversable LT?	N/A	N/A	Flare Traversable RT?	N/A
N/A	Landing Length (in)	N/A	N/A	DWS Provided?	N/A
N/A	Landing Width (in)	N/A	N/A	DWS Contrast?	N/A
N/A	Landing Slope (%)	N/A	N/A	DWS Length (in)	N/A
N/A	Landing X Slope (%)	N/A	N/A	DWS Full Width?	N/A
N/A	Landing Curb? (Y/N)	N/A	N/A	DWS Offset (in)	N/A
N/A	Shared Landing?	N/A			
N/A	Gutter Ponding?	N/A	N/A	Gutter Slope (%)	N/A
N/A	Gutter Lip Ht (in)	N/A	N/A	Gutter X Slope (%)	N/A
N/A	Painted X Walk1?	No	N/A	Painted X Walk2?	N/A
	X Walk 1 Direction	To N		X Walk 2 Direction	N/A
N/A	X Walk 1 Width (in)	N/A	N/A	X Walk 2 Width (in)	N/A
	X Walk 1 Slope (%)	2.3		X Walk 2 Slope (%)	N/A
	X Walk 1 X Slope (%)	0.8		X Walk 2 X Slope (%)	N/A

N/A	Ramp inside XWalk1?	N/A	N/A	Ramp inside XWalk2?	N/A
	Road Slope (%)	N/A	N/A	Clear Space?	N/A
	Road X Slope (%)	N/A	N/A	Clear Space to XWalk (in)	N/A
N/A	Any Obstructions?	N/A	N/A	Storm Grate/Utility Hazard?	N/A
	Obstruction Type			Storm Grate/Utility Type	
		N/A			N/A
			Yes	Surface Condition? (G/P)	Good

Remove & Replace Entire Ramp.
