Access Compliance Report Public Rights-of-Way (Curb Ramps)

Intersection ID: 10158 Main Street: MULBERRY CHURCH RD **Cross Street: TUCKASEEGEE RD** Location: SE Ramp Type: Perp Initial Pass/Fail: Fail **Overall Compliance: No Severity Score:** 12.5 ADA ID: 72466C66F171

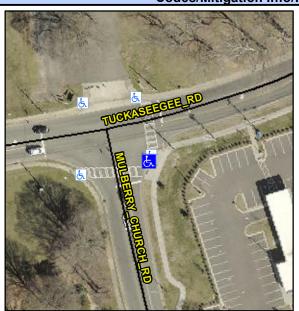
9.4

106.5 No

Ramp Slope (%)

Possible Solutions:	Compl	iance	Description
Remove & Replace Entire Ramp.	N/A	Ram	p Length (in)
·	Yes	Ram	p Width (in)
	N/A	Flare	Type LT
	N/A	Flare	Slope LT (%)
	N/A	Flare	Traversable LT
	N/A	Land	ing Length (in)
Surveyor Notes:	N/A	Land	ing Width (in)
N/A	N/A	Land	ing Slope (%)
	N/A	Land	ing X Slope (%)
	N/A	Land	ing Curb? (Y/N)
	N/A	Share	ed Landing?
PROW/ADA:	N/A	Gutte	er Ponding?
Not Found, R304.2.2	N/A	Gutte	er Lip Ht (in)
	N/A	Paint	ed X Walk1?
		X Wa	Ilk 1 Direction
	N/A	X Wa	ılk 1 Width (in)
		X Wa	ılk 1 Slope (%)
		X Wa	Ik 1 X Slone (%
