Access Compliance Report

Public Rights-of-Way

(Curb Ramps)

Intersection ID: 52442	Main Street: WOODWARD_AV	Cross Street: BENDING_BIRCH_PL	Location: W
ADA ID: 7254372C82A8	Ramp Type: Directional1	Initial Pass/Fail: Fail	Overall Compliance: No
			Severity Score: 13.75

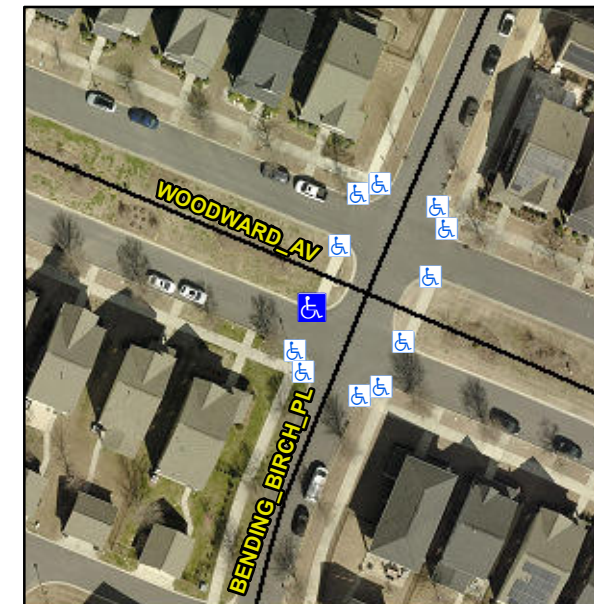
LOCATED ON MEDIAN

Compliance	Description	Data	Compliance	Description	Data
N/A	Ramp Length (in)	85.0	N/A	Grade Break?	N/A
Yes	Ramp Width (in)	60.0	N/A	Grade Break Slope (%)	0.0
No	Ramp Slope (%)	8.6	N/A	Grade Break XSlope (%)	0.0
Yes	Ramp XSlope (%)	4.6			
N/A	Flare Type LT	N/A	N/A	Flare Type RT	N/A
N/A	Flare Slope LT (%)	N/A	N/A	Flare Slope RT (%)	0.0
N/A	Flare Traversable LT?	N/A	N/A	Flare Traversable RT?	N/A
N/A	Landing Length (in)	0.0	N/A	DWS Provided?	N/A
N/A	Landing Width (in)	0.0	N/A	DWS Contrast?	N/A
N/A	Landing Slope (%)	0.0	N/A	DWS Length (in)	N/A
N/A	Landing X Slope (%)	0.0	N/A	DWS Full Width?	N/A
N/A	Landing Curb? (Y/N)	N/A	N/A	DWS Offset LT (in)	N/A
N/A	Shared Landing?	N/A	N/A	DWS Offset RT (in)	N/A
N/A	Gutter Ponding?	0.0	N/A	Gutter Slope (%)	N/A
N/A	Gutter Lip Ht (in)	0.0	N/A	Gutter X Slope (%)	N/A
N/A	Painted X Walk1?	No		Road Slope (%)	1.6
	X Walk 1 Direction	To S		Road X Slope (%)	5.4
	X Walk 1 Width (in)	N/A		Clear Space?	N/A

X Walk 1 Slope (%)	1.6	N/A	Clear Space to XWalk (in)	N/A
	X Walk 1 X Slope (%)	5.4	N/A	Storm Grate/Utility Hazard?	N/A
N/A	Ramp inside XWalk1?	N/A		Storm Grate/Utility Type	
N/A	Any Obstructions?	N/A			N/A
	Obstruction Type		Yes	Surface Condition? (G/P)	Good
			N/A	Curb Slope (%)	0.7

Possible Solutions:

Remove & Replace Entire Ramp.
