Access Compliance Report

Public Rights-of-Way (Curb Ramps)

Intersection ID: 48946	Main Street: DAVID_JENNINGS_AV	Cross Street: MITCHELL_GRANT_WY	Location: E
ADA ID: 7272BB3DFDB4	Ramp Type: BlendTrans1	Initial Pass/Fail: Fail	Overall Compliance: No
		Severity Score: 10

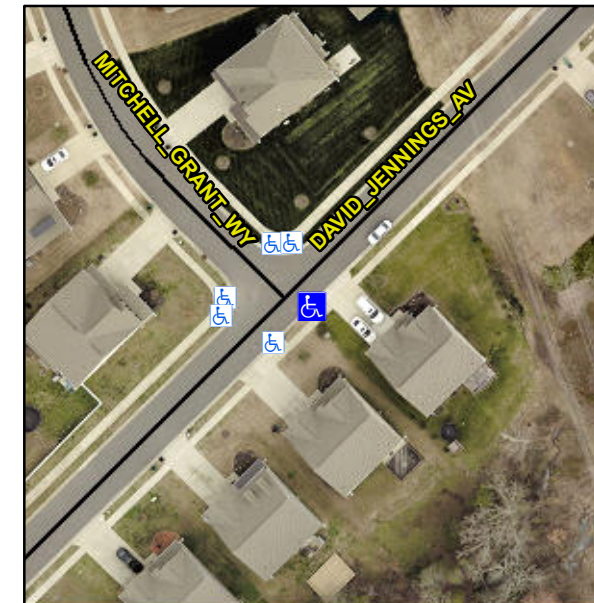
Compliance	Description	Data	Compliance	Description	Data
N/A	Ramp Length (in)	47.0	Yes	BlendTrans Slope (%)	2.2
No	Ramp Width (in)	47.5	Yes	BlendTrans XSlope (%)	2.9
N/A	Flare Type LT	N/A	N/A	Flare Type RT	N/A
N/A	Flare Slope LT (%)	N/A	N/A	Flare Slope RT (%)	N/A
N/A	Flare Traversable LT?	N/A	N/A	Flare Traversable RT?	N/A
N/A	Landing Length (in)	N/A	N/A	DWS Provided?	N/A
N/A	Landing Width (in)	N/A	N/A	DWS Contrast?	N/A
N/A	Landing Slope (%)	N/A	N/A	DWS Length (in)	N/A
N/A	Landing X Slope (%)	N/A	N/A	DWS Full Width?	N/A
N/A	Landing Curb? (Y/N)	N/A	N/A	DWS Offset (in)	N/A
N/A	Shared Landing?	N/A			
N/A	Gutter Ponding?	N/A	N/A	Gutter Slope (%)	N/A
N/A	Gutter Lip Ht (in)	N/A	N/A	Gutter X Slope (%)	N/A
N/A	Painted X Walk1?	No	N/A	Painted X Walk2?	N/A
	X Walk 1 Direction	To NW		X Walk 2 Direction	N/A
	X Walk 1 Width (in)	N/A		X Walk 2 Width (in)	N/A
	X Walk 1 Slope (%)	1.4		X Walk 2 Slope (%)	N/A
	X Walk 1 X Slope (%)	2.9		X Walk 2 X Slope (%)	N/A

N/A	Ramp inside XWalk1?	N/A	N/A	Ramp inside XWalk2?	N/A
	Road Slope (%)	2.9		Clear Space?	N/A
	Road X Slope (%)	1.4	N/A	Clear Space to XWalk (in)	N/A
N/A	Any Obstructions?	N/A	N/A	Storm Grate/Utility Hazard?	N/A
	Obstruction Type			Storm Grate/Utility Type	
		N/A			N/A
			Yes	Surface Condition? (G/P)	Good
			No	Curb Slope (%)	20.2

Remove & Replace Curb Ramp With Two New Directional Ramps or Equivalent.
