Access Compliance Report

Public Rights-of-Way

(Curb Ramps)

Intersection ID: 10257	Main Street: E_36TH_ST	Cross Street: N_MCDOWELL_ST	Location: E
ADA ID: 7287E420BC44	Ramp Type: PerpDiag	Initial Pass/Fail: Fail	Overall Compliance: No
		Severity Score: 12.5	
Codes/Mitigation Info/Possible Solution		Field Measurements/Component Compliance

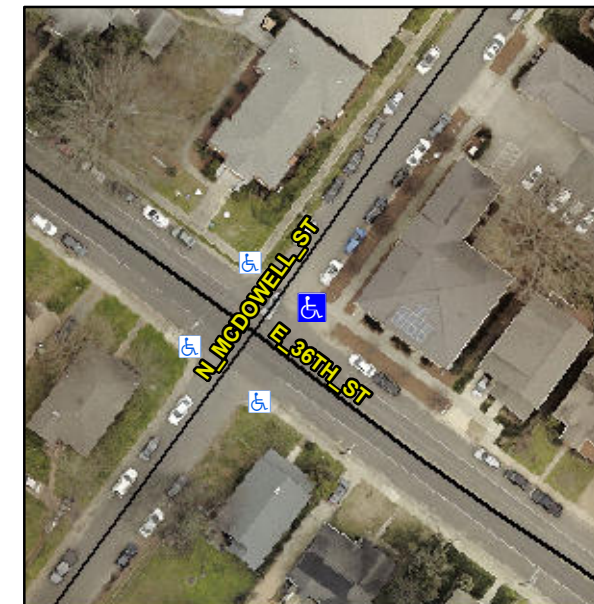
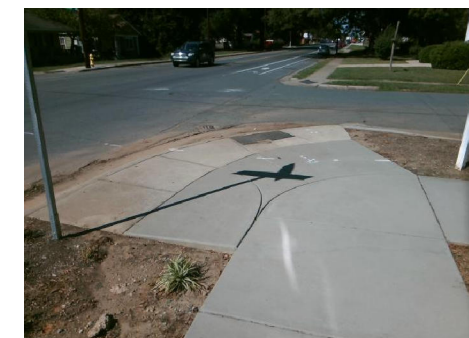
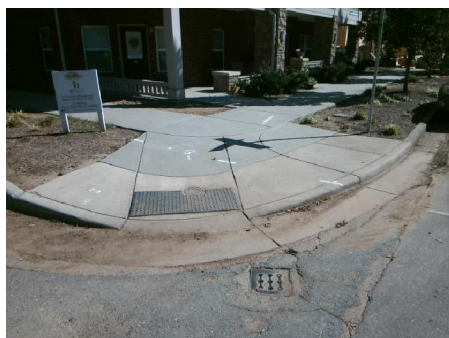
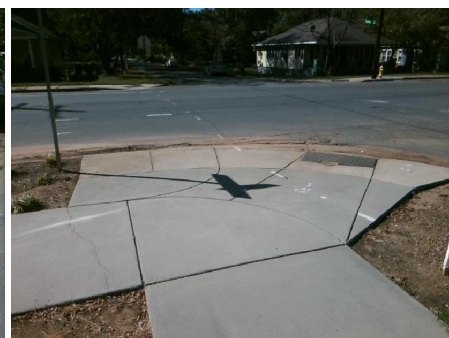
Not Found, R304.5.3

Compliance	Description	Data	Compliance	Description	Data
N/A	Ramp Length (in)	120.0	Yes	Ramp Slope (%)	6.4
Yes	Ramp Width (in)	48.0	No	Ramp XSlope (%)	5.2
N/A	Flare Type LT	N/A	N/A	Flare Type RT	N/A
N/A	Flare Slope LT (%)	N/A	N/A	Flare Slope RT (%)	N/A
N/A	Flare Traversable LT?	N/A	N/A	Flare Traversable RT?	N/A
N/A	Landing Length (in)	N/A	N/A	DWS Provided?	N/A
N/A	Landing Width (in)	N/A	N/A	DWS Contrast?	N/A
N/A	Landing Slope (%)	N/A	N/A	DWS Length (in)	N/A
N/A	Landing X Slope (%)	N/A	N/A	DWS Full Width?	N/A
N/A	Landing Curb? (Y/N)	N/A	N/A	DWS Offset (in)	N/A
N/A	Shared Landing?	N/A			
N/A	Gutter Ponding?	Yes	N/A	Gutter Slope (%)	N/A
N/A	Gutter Lip Ht (in)	0.5	N/A	Gutter X Slope (%)	N/A
N/A	Painted X Walk1?	No	N/A	Painted X Walk2?	No
	X Walk 1 Direction	To NW		X Walk 2 Direction	To SW
N/A	X Walk 1 Width (in)	N/A	N/A	X Walk 2 Width (in)	N/A
	X Walk 1 Slope (%)	0.1		X Walk 2 Slope (%)	2.5
	X Walk 1 X Slope (%)	2.7		X Walk 2 X Slope (%)	0.2

N/A	Ramp inside XWalk1?	N/A	N/A	Ramp inside XWalk2?	N/A
	Road Slope (%)	1.6	N/A	Clear Space?	N/A
	Road X Slope (%)	2.1	N/A	Clear Space to XWalk (in)	N/A
N/A	Any Obstructions?	N/A	N/A	Storm Grate/Utility Hazard?	N/A
	Obstruction Type			Storm Grate/Utility Type	
		N/A			N/A
		Yes		Surface Condition? (G/P)	Good

Remove & Replace Curb Ramp With Two New Directional Ramps or Equivalent.

Total Cost: \$ 3200.00
