Access Compliance Report

Public Rights-of-Way

(Curb Ramps)

Intersection ID: 20407	Main Street: CAMERON_VALLEY_PY	Cross Street: COLTSGATE_RD	Location: SE
ADA ID: 728956BC2D51	Ramp Type: PerpDiag	Initial Pass/Fail: Fail	Overall Compliance: No
Severity Score: 17.5			
Codes/Mitigation Info/Possible Solution		Field Measurements/Component Compliance

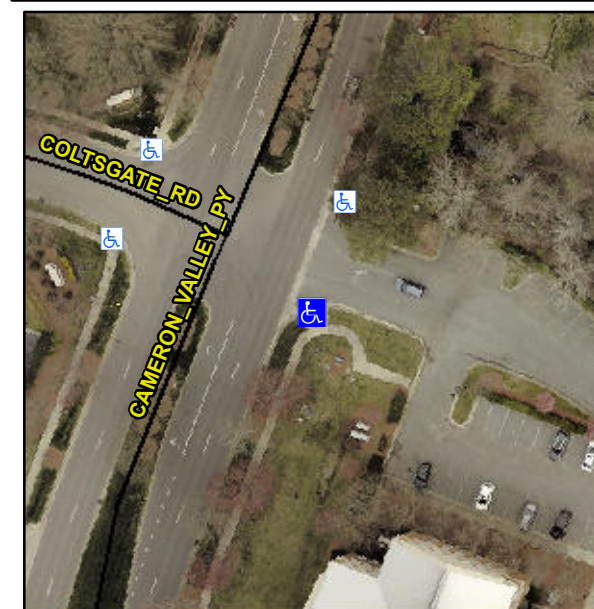
Compliance	Description	Data	Compliance	Description	Data
N/A	Ramp Length (in)	114.0	Yes	Ramp Slope (%)	8.2
No	Ramp Width (in)	35.5	Yes	Ramp XSlope (%)	0.3
N/A	Flare Type LT	N/A	N/A	Flare Type RT	N/A
N/A	Flare Slope LT (%)	N/A	N/A	Flare Slope RT (%)	N/A
N/A	Flare Traversable LT?	N/A	N/A	Flare Traversable RT?	N/A
N/A	Landing Length (in)	N/A	N/A	DWS Provided?	N/A
N/A	Landing Width (in)	N/A	N/A	DWS Contrast?	N/A
N/A	Landing Slope (%)	N/A	N/A	DWS Length (in)	N/A
N/A	Landing X Slope (%)	N/A	N/A	DWS Full Width?	N/A
N/A	Landing Curb? (Y/N)	N/A	N/A	DWS Offset (in)	N/A
N/A	Shared Landing?	N/A			
N/A	Gutter Ponding?	N/A	N/A	Gutter Slope (%)	N/A
N/A	Gutter Lip Ht (in)	N/A	N/A	Gutter X Slope (%)	N/A
N/A	Painted X Walk1?	No	N/A	Painted X Walk2?	No
	X Walk 1 Direction	To NE		X Walk 2 Direction	To NW
N/A	X Walk 1 Width (in)	N/A	N/A	X Walk 2 Width (in)	N/A
	X Walk 1 Slope (%)	0.1		X Walk 2 Slope (%)	2.6
	X Walk 1 X Slope (%)	3.5		X Walk 2 X Slope (%)	1.6

N/A	Ramp inside XWalk1?	N/A	N/A	Ramp inside XWalk2?	N/A
	Road Slope (%)	2.0	N/A	Clear Space?	N/A
	Road X Slope (%)	1.9	N/A	Clear Space to XWalk (in)	N/A
N/A	Any Obstructions?	N/A	N/A	Storm Grate/Utility Hazard?	N/A
	Obstruction Type			Storm Grate/Utility Type	
		N/A			N/A
			Yes	Surface Condition? (G/P)	Good

Possible Solutions:

Remove & Replace Curb Ramp With Two New Directional Ramps or Equivalent.
