# Access Compliance Report

## Public Rights-of-Way

### (Curb Ramps)

Intersection ID: 45830	Main Street: EMMA_LYNN_CT	Cross Street: CHRISTENBURY_HILLS_LN	Location: SE
ADA ID: 72914C38A2FB	Ramp Type: Perp	Initial Pass/Fail: Fail	Overall Compliance: No
Severity Score: 25			
Codes/Mitigation Info/Possible Solution		Field Measurements/Component Compliance

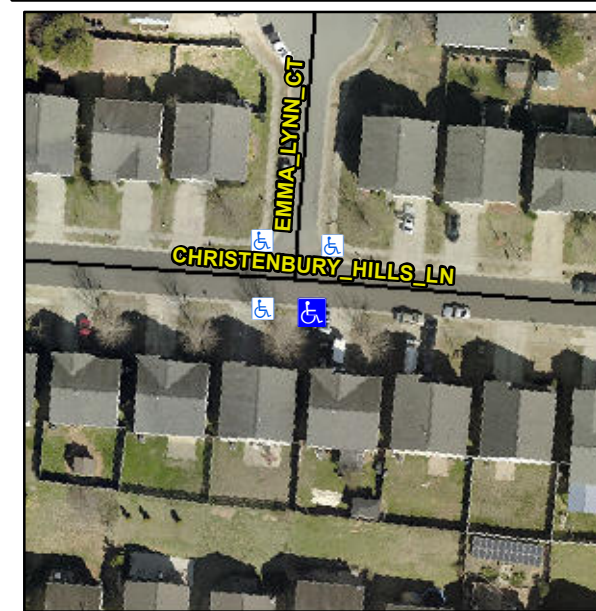
**Not Found, R304.2.2, R304.5.3**

Compliance	Description	Data	Compliance	Description	Data
N/A	Ramp Length (in)	49.0	No	Ramp Slope (%)	10.3
Yes	Ramp Width (in)	48.0	No	Ramp XSlope (%)	5.1
N/A	Flare Type LT	N/A	N/A	Flare Type RT	N/A
N/A	Flare Slope LT (%)	N/A	N/A	Flare Slope RT (%)	N/A
N/A	Flare Traversable LT?	N/A	N/A	Flare Traversable RT?	N/A
N/A	Landing Length (in)	N/A	N/A	DWS Provided?	N/A
N/A	Landing Width (in)	N/A	N/A	DWS Contrast?	N/A
N/A	Landing Slope (%)	N/A	N/A	DWS Length (in)	N/A
N/A	Landing X Slope (%)	N/A	N/A	DWS Full Width?	N/A
N/A	Landing Curb? (Y/N)	N/A	N/A	DWS Offset (in)	N/A
N/A	Shared Landing?	N/A			
N/A	Gutter Ponding?	N/A	N/A	Gutter Slope (%)	N/A
N/A	Gutter Lip Ht (in)	N/A	N/A	Gutter X Slope (%)	N/A
N/A	Painted X Walk1?	No	N/A	Painted X Walk2?	N/A
	X Walk 1 Direction	To N		X Walk 2 Direction	N/A
N/A	X Walk 1 Width (in)	N/A	N/A	X Walk 2 Width (in)	N/A
	X Walk 1 Slope (%)	4.3		X Walk 2 Slope (%)	N/A
	X Walk 1 X Slope (%)	5.1		X Walk 2 X Slope (%)	N/A

N/A	Ramp inside XWalk1?	N/A	N/A	Ramp inside XWalk2?	N/A
	Road Slope (%)	N/A	N/A	Clear Space?	N/A
	Road X Slope (%)	N/A	N/A	Clear Space to XWalk (in)	N/A
N/A	Any Obstructions?	N/A	N/A	Storm Grate/Utility Hazard?	N/A
	Obstruction Type			Storm Grate/Utility Type	
		N/A			N/A
			Yes	Surface Condition? (G/P)	Good

**Remove & Replace Entire Ramp.**

Total Cost: \$ 1850.00
