Access Compliance Report

Public Rights-of-Way

(Curb Ramps)

| Intersection ID: 14165 | Main Street: BARNETTE_PL | Cross Street: E_4TH_ST | Location: | S |

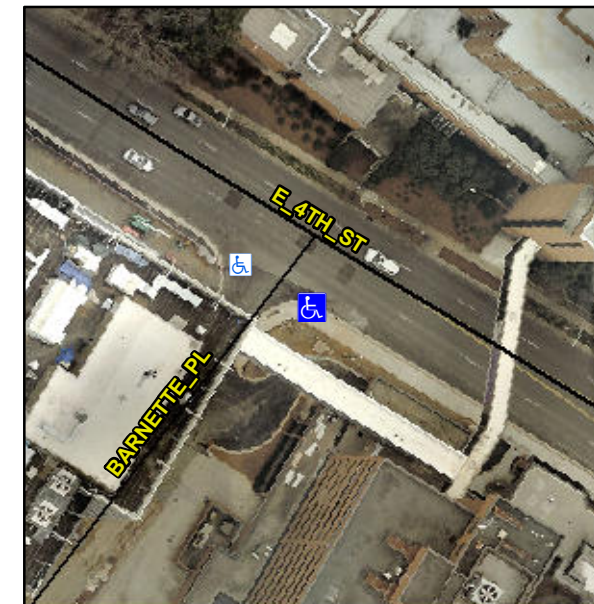
Not Found, R304.5.1, R304.2.2, R304.5.3

| Compliance | Description | Data | Compliance | Description | Data |
|---|---|---|---|---|---|
| N/A | Ramp Length (in) | 54.0 | No | Ramp Slope (%) | 11.4 |
| No | Ramp Width (in) | 41.0 | No | Ramp XSlope (%) | 4.4 |

Remove & Replace Curb Ramp With Two New Directional Ramps or Equivalent.
