Access Compliance Report

Public Rights-of-Way

(Curb Ramps)

Intersection ID: 4106	Main Street: CLAYBROOKE_DR	Cross Street: TURNING_LEAF_CT	Location: SE
ADA ID: 72938918859C	Ramp Type: Perp	Initial Pass/Fail: Fail	Overall Compliance: No
Severity Score: 21.25			
Codes/Mitigation Info/Possible Solution		Field Measurements/Component Compliance

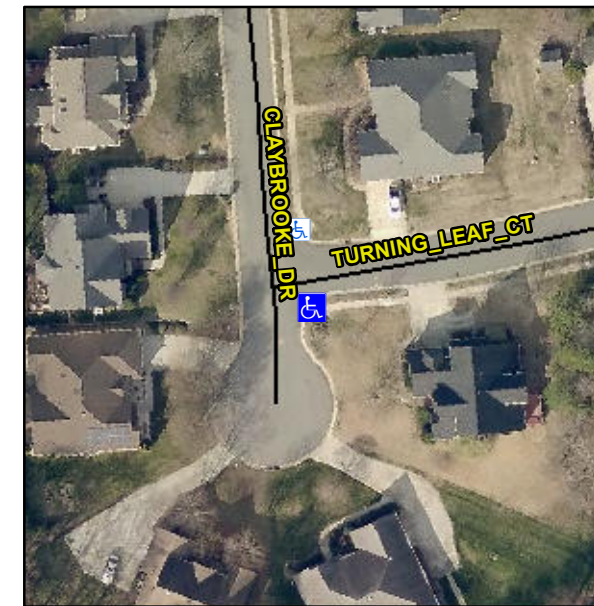
Not Found, R304.5.1, R304.5.3

Compliance	Description	Data	Compliance	Description	Data
N/A	Ramp Length (in)	91.0	Yes	Ramp Slope (%)	5.3
No	Ramp Width (in)	38.0	No	Ramp XSlope (%)	6.2
N/A	Flare Type LT	N/A	N/A	Flare Type RT	N/A
N/A	Flare Slope LT (%)	N/A	N/A	Flare Slope RT (%)	N/A
N/A	Flare Traversable LT?	N/A	N/A	Flare Traversable RT?	N/A
N/A	Landing Length (in)	N/A	N/A	DWS Provided?	N/A
N/A	Landing Width (in)	N/A	N/A	DWS Contrast?	N/A
N/A	Landing Slope (%)	N/A	N/A	DWS Length (in)	N/A
N/A	Landing X Slope (%)	N/A	N/A	DWS Full Width?	N/A
N/A	Landing Curb? (Y/N)	N/A	N/A	DWS Offset (in)	N/A
N/A	Shared Landing?	N/A			
N/A	Gutter Ponding?	N/A	N/A	Gutter Slope (%)	N/A
N/A	Gutter Lip Ht (in)	N/A	N/A	Gutter X Slope (%)	N/A
N/A	Painted X Walk1?	No	N/A	Painted X Walk2?	N/A
	X Walk 1 Direction	To N		X Walk 2 Direction	N/A
N/A	X Walk 1 Width (in)	N/A	N/A	X Walk 2 Width (in)	N/A
	X Walk 1 Slope (%)	1.3		X Walk 2 Slope (%)	N/A
	X Walk 1 X Slope (%)	7.8		X Walk 2 X Slope (%)	N/A

N/A	Ramp inside XWalk1?	N/A	N/A	Ramp inside XWalk2?	N/A
	Road Slope (%)	N/A	N/A	Clear Space?	N/A
	Road X Slope (%)	N/A	N/A	Clear Space to XWalk (in)	N/A
N/A	Any Obstructions?	N/A	N/A	Storm Grate/Utility Hazard?	N/A
	Obstruction Type			Storm Grate/Utility Type	
		N/A			N/A
			Yes	Surface Condition? (G/P)	Good

Remove & Replace Entire Ramp.
