## **Access Compliance Report Public Rights-of-Way** (Curb Ramps)

Intersection ID: 5433 Main Street: PLEASANT GROVE RD **Cross Street: OLD PLANK RD** Location: SE ADA ID: 729A82B60B82 Ramp Type: BlendTrans1 Initial Pass/Fail: Fail **Overall Compliance: No** 10 **Severity Score:**

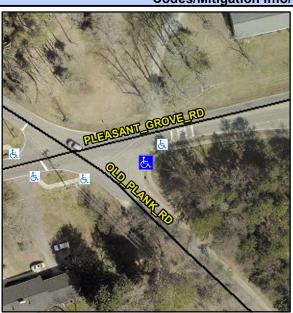
**OLD PLANK RD** Street 1 Name Stop Condition-Street 1 StopSign Street 2 Name N/A Stop Condition-Street 2 N/A Possible Solutions: Compliance Description Remove & Replace Curb Ramp With N/A Two New Directional Ramps or No Equivalent. Surveyor Notes: **CURB LIP 0.5** PROW/ADA: Not Found, R304.5.1, R304.5.3
