# Access Compliance Report

## Public Rights-of-Way

### (Curb Ramps)

Intersection ID: 46950	Main Street: RED_BIRD_TL	Cross Street: OLDE_WHITE_LN	Location:	N
ADA ID: 729BDA355E3A	Ramp Type: PerpDiag	Initial Pass/Fail: Fail	Overall Compliance: No	Severity Score: 10
Codes/Mitigation Info/Possible Solution		Field Measurements/Component Compliance

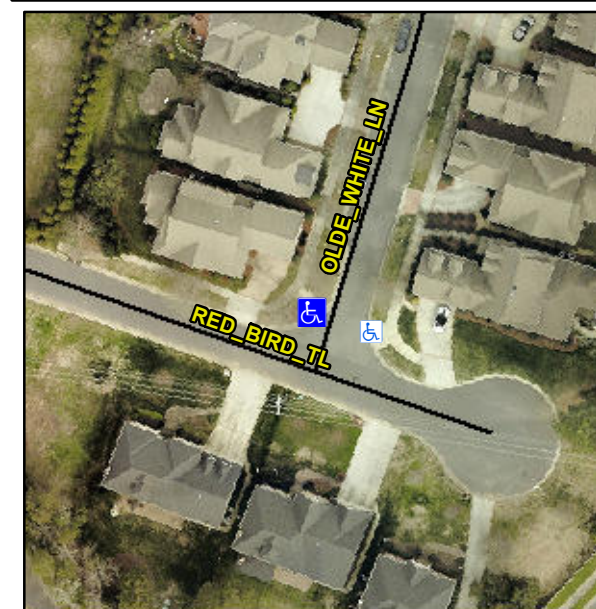
**Not Found, R304.5.1, R304.5.3**

Compliance	Description	Data	Compliance	Description	Data
N/A	Ramp Length (in)	53.0	Yes	Ramp Slope (%)	5.5
No	Ramp Width (in)	47.0	No	Ramp XSlope (%)	3.0
N/A	Flare Type LT	N/A	N/A	Flare Type RT	N/A
N/A	Flare Slope LT (%)	N/A	N/A	Flare Slope RT (%)	N/A
N/A	Flare Traversable LT?	N/A	N/A	Flare Traversable RT?	N/A
N/A	Landing Length (in)	N/A	N/A	DWS Provided?	N/A
N/A	Landing Width (in)	N/A	N/A	DWS Contrast?	N/A
N/A	Landing Slope (%)	N/A	N/A	DWS Length (in)	N/A
N/A	Landing X Slope (%)	N/A	N/A	DWS Full Width?	N/A
N/A	Landing Curb? (Y/N)	N/A	N/A	DWS Offset (in)	N/A
N/A	Shared Landing?	N/A			
N/A	Gutter Ponding?	N/A	N/A	Gutter Slope (%)	N/A
N/A	Gutter Lip Ht (in)	N/A	N/A	Gutter X Slope (%)	N/A
N/A	Painted X Walk1?	No	N/A	Painted X Walk2?	No
	X Walk 1 Direction	To S		X Walk 2 Direction	To SE
N/A	X Walk 1 Width (in)	N/A	N/A	X Walk 2 Width (in)	N/A
	X Walk 1 Slope (%)	7.7		X Walk 2 Slope (%)	4.2
	X Walk 1 X Slope (%)	2.8		X Walk 2 X Slope (%)	6.6

N/A	Ramp inside XWalk1?	N/A	N/A	Ramp inside XWalk2?	N/A
	Road Slope (%)	6.4	N/A	Clear Space?	N/A
	Road X Slope (%)	7.0	N/A	Clear Space to XWalk (in)	N/A
N/A	Any Obstructions?	N/A	N/A	Storm Grate/Utility Hazard?	N/A
	Obstruction Type			Storm Grate/Utility Type	
		N/A			N/A
			Yes	Surface Condition? (G/P)	Good

**Remove & Replace Curb Ramp With Two New Directional Ramps or Equivalent.**

Total Cost: \$ 3200.00
