# Access Compliance Report

## Public Rights-of-Way

### (Curb Ramps)

Intersection ID: 10028782	Main Street: HUNTINGTOWNE_FARMS_LN	Cross Street: N/A	Location: SE
ADA ID: 729EBFF6F018	Ramp Type: BlendTrans1	Initial Pass/Fail: Fail	Overall Compliance: No
Severity Score: 12.5			
Codes/Mitigation Info/Possible Solution		Field Measurements/Component Compliance

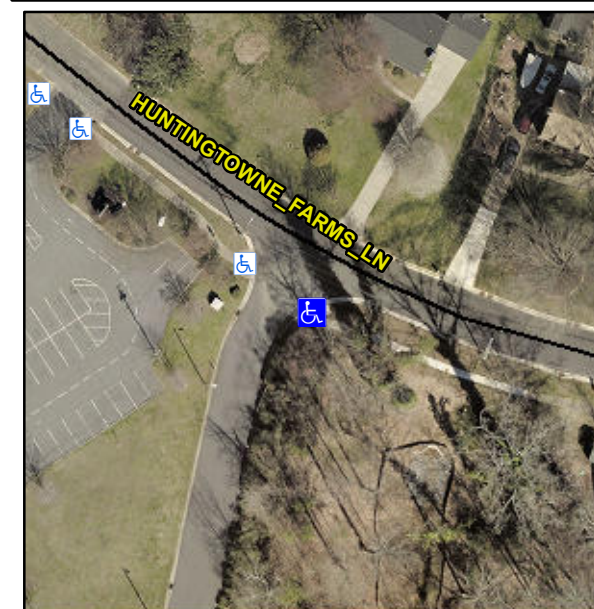
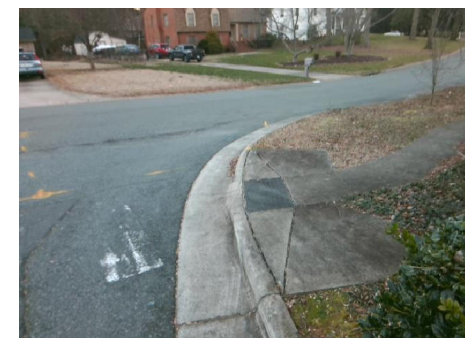
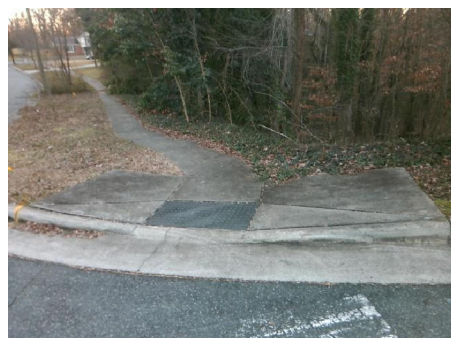
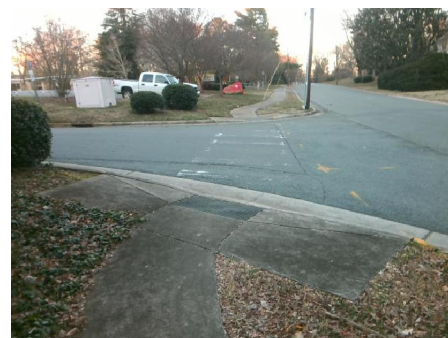
**Not Found, R304.5.3**

Compliance	Description	Data	Compliance	Description	Data
N/A	Ramp Length (in)	60.0	Yes	BlendTrans Slope (%)	3.5
Yes	Ramp Width (in)	48.0	No	BlendTrans XSlope (%)	6.0
N/A	Flare Type LT	N/A	N/A	Flare Type RT	N/A
N/A	Flare Slope LT (%)	N/A	N/A	Flare Slope RT (%)	N/A
N/A	Flare Traversable LT?	N/A	N/A	Flare Traversable RT?	N/A
N/A	Landing Length (in)	N/A	N/A	DWS Provided?	N/A
N/A	Landing Width (in)	N/A	N/A	DWS Contrast?	N/A
N/A	Landing Slope (%)	N/A	N/A	DWS Length (in)	N/A
N/A	Landing X Slope (%)	N/A	N/A	DWS Full Width?	N/A
N/A	Landing Curb? (Y/N)	N/A	N/A	DWS Offset (in)	N/A
N/A	Shared Landing?	N/A			
N/A	Gutter Ponding?	N/A	N/A	Gutter Slope (%)	N/A
N/A	Gutter Lip Ht (in)	N/A	N/A	Gutter X Slope (%)	N/A
N/A	Painted X Walk1?	No	N/A	Painted X Walk2?	Yes
	X Walk 1 Direction	To NE		X Walk 2 Direction	To NW
	X Walk 1 Width (in)	N/A		X Walk 2 Width (in)	92.0
	X Walk 1 Slope (%)	5.8		X Walk 2 Slope (%)	2.6
	X Walk 1 X Slope (%)	3.1		X Walk 2 X Slope (%)	5.5

N/A	Ramp inside XWalk1?	N/A	N/A	Ramp inside XWalk2?	Yes
	Road Slope (%)	6.8		Clear Space?	N/A
	Road X Slope (%)	0.9	N/A	Clear Space to XWalk (in)	N/A
N/A	Any Obstructions?	N/A	N/A	Storm Grate/Utility Hazard?	N/A
	Obstruction Type			Storm Grate/Utility Type	
		N/A			N/A
			Yes	Surface Condition? (G/P)	Good
			No	Curb Slope (%)	9.3

**Remove & Replace Curb Ramp With Two New Directional Ramps or Equivalent.**
