# Access Compliance Report

## Public Rights-of-Way

### (Curb Ramps)

| Intersection ID: 12244 | Main Street: BELMONT_AV | Cross Street: HARRILL_ST | Location: E |

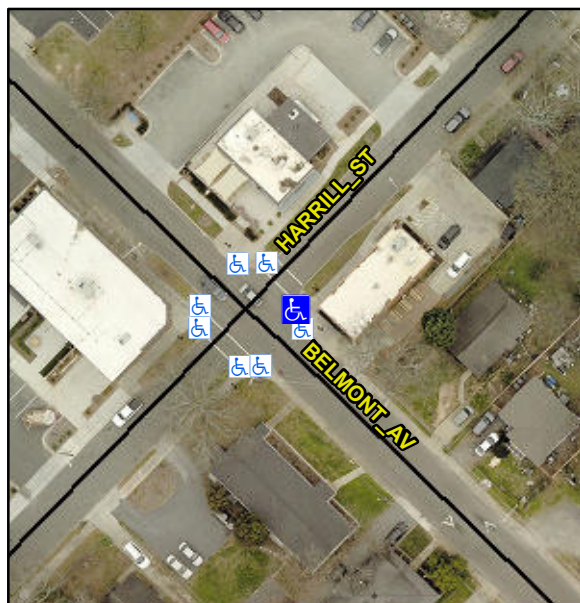
| ADA ID: 729EDA5DB5D8 | Ramp Type: Directional1 | Initial Pass/Fail: Pass | Overall Compliance: No |
| Severity Score: 5 | | | |

| Compliance | Description | Data | Compliance | Description | Data |
|---|---|---|---|---|---|
| Yes | Ramp Width (in) | 59.0 | No | Grade Break Slope (%) | 8.6 |
| No | Landing Slope (%) | 2.2 | Yes | DWS Length (in) | 24.0 |
| Yes | Gutter Lip Ht (in) | 0.0 | No | Gutter X Slope (%) | 3.4 |

Possible Solutions:

**Remove & Replace Entire Ramp.  
Remove & Replace Gutter.**
