Access Compliance Report Public Rights-of-Way (Curb Ramps)

Intersection ID: 31722 Main Street: FILBERT_LN Cross Street: WEEPING_FIG_LN Location: SE

ADA ID: 72AD6D9575BF Ramp Type: Perp Initial Pass/Fail: Fail Overall Compliance: No Severity Score: 25

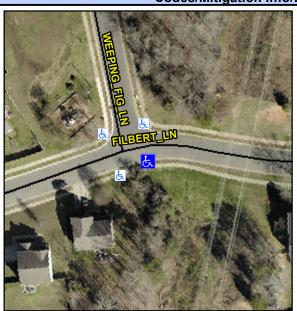
Compl	iance Description	Data	Comp	liance	Description	Data
N/A	Ramp Length (in)	48.0	No	Ramp	Slope (%)	12.6
Yes	Ramp Width (in)	48.0	Yes	Ramp	XSlope (%)	0.4
N/A	Flare Type LT	N/A	N/A	Flare	Type RT	N/A
N/A	Flare Slope LT (%)	N/A	N/A	Flare	Slope RT (%)	N/A
N/A	Flare Traversable LT?	N/A	N/A	Flare	Traversable RT?	N/A
N/A	Landing Length (in)	N/A	N/A	DWS	Provided?	N/A
N/A	Landing Width (in)	N/A	N/A	DWS	Contrast?	N/A
N/A	Landing Slope (%)	N/A	N/A	DWS	Length (in)	N/A
N/A	Landing X Slope (%)	N/A	N/A	DWS	Full Width?	N/A
N/A	Landing Curb? (Y/N)	N/A	N/A	DWS	Offset (in)	N/A
N/A	Shared Landing?	N/A				
N/A	Gutter Ponding?	N/A	N/A	Gutte	r Slope (%)	N/A
N/A	Gutter Lip Ht (in)	N/A	N/A	Gutte	r X Slope (%)	N/A
N/A	Painted X Walk1?	No	N/A	Paint	ed X Walk2?	N/A
	X Walk 1 Direction	To N		X Wa	lk 2 Direction	N/A
N/A	X Walk 1 Width (in)	N/A	N/A	X Wa	lk 2 Width (in)	N/A
	X Walk 1 Slope (%)	3.6		X Wa	lk 2 Slope (%)	N/A
	X Walk 1 X Slope (%)	1.0		X Wa	lk 2 X Slope (%)	N/A

71 COOLDIC COLUCION	
Possible Solutions:	
Remove & Replace Entire Ramp.	
Surveyor Notes:	
N/A	
PROW/ADA:	
Not Found, R304.2.2
