# Access Compliance Report

## Public Rights-of-Way

### (Curb Ramps)

Intersection ID: N/A	Main Street: MINERAL_SPRINGS_RD	Cross Street: BURGANDY_DR	Location: SE
ADA ID: 72B0BCF75B5C	Ramp Type: Directional1	Initial Pass/Fail: Pass	Overall Compliance: No
Severity Score: 5.25			
Codes/Mitigation Info/Possible Solution		Field Measurements/Component Compliance

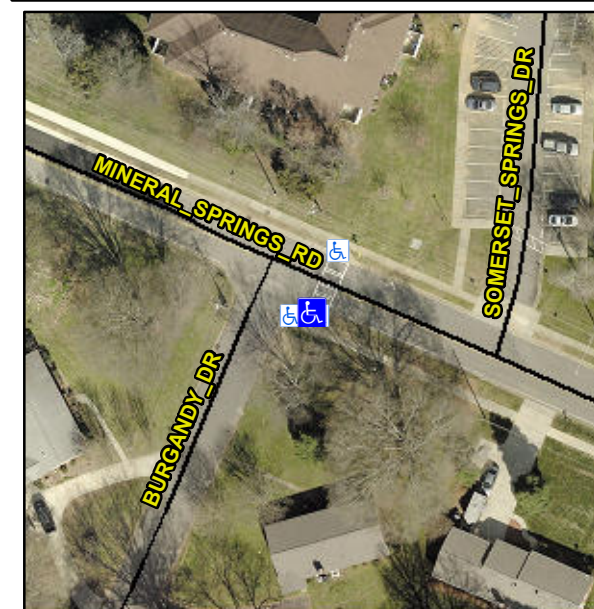
Compliance	Description	Data	Compliance	Description	Data
N/A	Ramp Length (in)	65.0	Yes	Grade Break?	Yes
Yes	Ramp Width (in)	57.0	Yes	Grade Break Slope (%)	4.3
Yes	Ramp Slope (%)	3.7	Yes	Grade Break XSlope (%)	0.5
Yes	Ramp XSlope (%)	3.0			
Yes	Flare Type LT	N/A	No	Flare Type RT	N/A
N/A	Flare Slope LT (%)	N/A	N/A	Flare Slope RT (%)	N/A
N/A	Flare Traversable LT?	No	N/A	Flare Traversable RT?	No
Yes	Landing Length (in)	55.5	Yes	DWS Provided?	Yes
Yes	Landing Width (in)	57.5	Yes	DWS Contrast?	Yes
No	Landing Slope (%)	3.7	Yes	DWS Length (in)	24.0
Yes	Landing X Slope (%)	1.4	Yes	DWS Full Width?	Yes
N/A	Landing Curb? (Y/N)	N/A	Yes	DWS Offset LT (in)	18.0
N/A	Shared Landing?	Yes	Yes	DWS Offset RT (in)	1.0
Yes	Gutter Ponding?	No	Yes	Gutter Slope (%)	0.7
Yes	Gutter Lip Ht (in)	0.0	Yes	Gutter X Slope (%)	1.5
N/A	Painted X Walk1?	Yes		Road Slope (%)	4.6
	X Walk 1 Direction	To N		Road X Slope (%)	3.5
	X Walk 1 Width (in)	111.0		Clear Space?	Yes

X Walk 1 Slope (%)	4.6	N/A	Clear Space to XWalk (in)	N/A
	X Walk 1 X Slope (%)	3.5	Yes	Storm Grate/Utility Hazard?	No
Yes	Ramp inside XWalk1?	Yes		Storm Grate/Utility Type	
Yes	Any Obstructions?	No			N/A
	Obstruction Type		Yes	Surface Condition? (G/P)	Good
			N/A	Curb Slope (%)	6.0

Possible Solutions:

**Remove & Replace Entire Ramp.**

**R304.2.2-Perp, R304.3.2-Para, R304.2.3**
