Intersection ID: 27461	Main Street: BRUSH_HOLLOW_RD	Cross Street: FAWN_HILL_RD	Location:	N
ADA ID: 72B330AD9879	Ramp Type: Perp	Initial Pass/Fail: Fail	Overall Compliance: No	Severity Score: 8.75

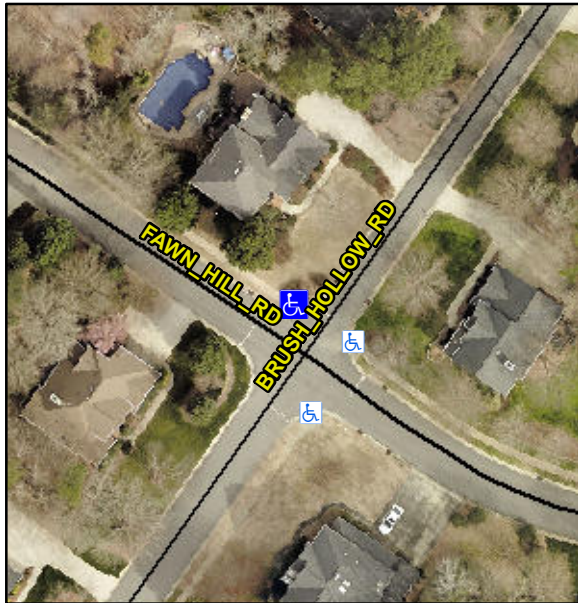
**Not Found, R304.5.1**

Compliance	Description	Data	Compliance	Description	Data
N/A	Ramp Length (in)	60.0	Yes	Ramp Slope (%)	5.7
No	Ramp Width (in)	47.0	Yes	Ramp XSlope (%)	1.6
N/A	Flare Type LT	N/A	N/A	Flare Type RT	N/A
N/A	Flare Slope LT (%)	N/A	N/A	Flare Slope RT (%)	N/A
N/A	Flare Traversable LT?	N/A	N/A	Flare Traversable RT?	N/A
N/A	Landing Length (in)	N/A	N/A	DWS Provided?	N/A
N/A	Landing Width (in)	N/A	N/A	DWS Contrast?	N/A
N/A	Landing Slope (%)	N/A	N/A	DWS Length (in)	N/A
N/A	Landing X Slope (%)	N/A	N/A	DWS Full Width?	N/A
N/A	Landing Curb? (Y/N)	N/A	N/A	DWS Offset (in)	N/A
N/A	Shared Landing?	N/A			
N/A	Gutter Ponding?	N/A	N/A	Gutter Slope (%)	N/A
N/A	Gutter Lip Ht (in)	N/A	N/A	Gutter X Slope (%)	N/A
N/A	Painted X Walk1?	No	N/A	Painted X Walk2?	N/A
	X Walk 1 Direction	To SE		X Walk 2 Direction	N/A
N/A	X Walk 1 Width (in)	N/A	N/A	X Walk 2 Width (in)	N/A
	X Walk 1 Slope (%)	4.2		X Walk 2 Slope (%)	N/A
	X Walk 1 X Slope (%)	1.3		X Walk 2 X Slope (%)	N/A

N/A	Ramp inside XWalk1?	N/A	N/A	Ramp inside XWalk2?	N/A
	Road Slope (%)	N/A	N/A	Clear Space?	N/A
	Road X Slope (%)	N/A	N/A	Clear Space to XWalk (in)	N/A
N/A	Any Obstructions?	N/A	N/A	Storm Grate/Utility Hazard?	N/A
	Obstruction Type			Storm Grate/Utility Type	
		N/A			N/A
			Yes	Surface Condition? (G/P)	Good

### Remove & Replace Entire Ramp.
