Access Compliance Report

Public Rights-of-Way

(Curb Ramps)

Intersection ID: 3051	Main Street: WHITE_STAG_DR	Cross Street: WHITE_STAG_DR	Location: NE
ADA ID: 72B6167C7EA2	Ramp Type: Perp	Initial Pass/Fail: Fail	Overall Compliance: No
Severity Score: 10			
Codes/Mitigation Info/Possible Solution		Field Measurements/Component Compliance

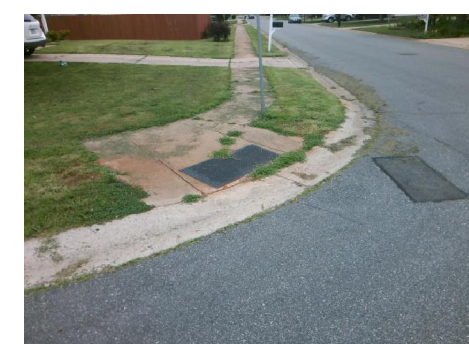
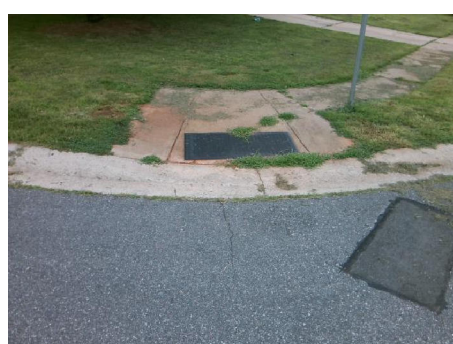
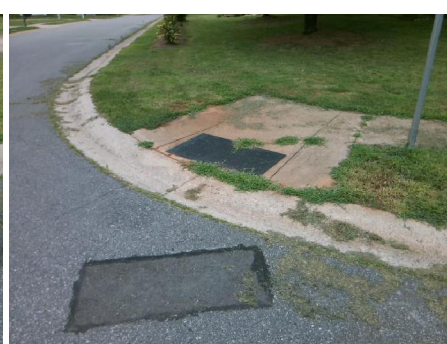
Not Found, R304.5.1, R304.5.3

Compliance	Description	Data	Compliance	Description	Data
N/A	Ramp Length (in)	47.0	Yes	Ramp Slope (%)	5.4
No	Ramp Width (in)	47.0	No	Ramp XSlope (%)	3.2
N/A	Flare Type LT	N/A	N/A	Flare Type RT	N/A
N/A	Flare Slope LT (%)	N/A	N/A	Flare Slope RT (%)	N/A
N/A	Flare Traversable LT?	N/A	N/A	Flare Traversable RT?	N/A
N/A	Landing Length (in)	N/A	N/A	DWS Provided?	N/A
N/A	Landing Width (in)	N/A	N/A	DWS Contrast?	N/A
N/A	Landing Slope (%)	N/A	N/A	DWS Length (in)	N/A
N/A	Landing X Slope (%)	N/A	N/A	DWS Full Width?	N/A
N/A	Landing Curb? (Y/N)	N/A	N/A	DWS Offset (in)	N/A
N/A	Shared Landing?	N/A			
N/A	Gutter Ponding?	N/A	N/A	Gutter Slope (%)	N/A
N/A	Gutter Lip Ht (in)	N/A	N/A	Gutter X Slope (%)	N/A
N/A	Painted X Walk1?	No	N/A	Painted X Walk2?	N/A
	X Walk 1 Direction	To W		X Walk 2 Direction	N/A
N/A	X Walk 1 Width (in)	N/A	N/A	X Walk 2 Width (in)	N/A
	X Walk 1 Slope (%)	3.7		X Walk 2 Slope (%)	N/A
	X Walk 1 X Slope (%)	4.0		X Walk 2 X Slope (%)	N/A

N/A	Ramp inside XWalk1?	N/A	N/A	Ramp inside XWalk2?	N/A
	Road Slope (%)	N/A	N/A	Clear Space?	N/A
	Road X Slope (%)	N/A	N/A	Clear Space to XWalk (in)	N/A
N/A	Any Obstructions?	N/A	N/A	Storm Grate/Utility Hazard?	N/A
	Obstruction Type			Storm Grate/Utility Type	
		N/A			N/A
			Yes	Surface Condition? (G/P)	Good

Possible Solutions:

Remove & Replace Entire Ramp.

Total Cost: \$ 1850.00
