Access Compliance Report

Public Rights-of-Way

(Curb Ramps)

Intersection ID: 12278	Main Street: SEIGLE_AV	Cross Street: VAN_EVERY_ST	Location:	N
ADA ID: 72B7E5D3A2EF	Ramp Type: Perp	Initial Pass/Fail: Fail	Overall Compliance: No	Severity Score: 25

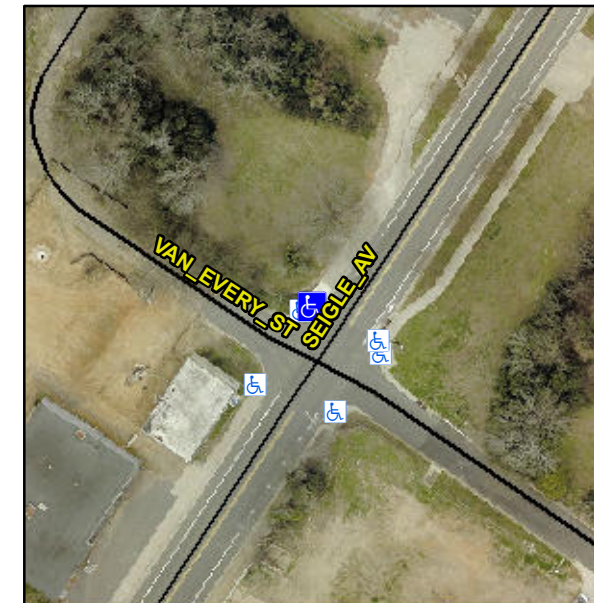
Not Found, R304.5.3

Compliance	Description	Data	Compliance	Description	Data
N/A	Ramp Length (in)	52.5	Yes	Ramp Slope (%)	5.8
Yes	Ramp Width (in)	48.0	No	Ramp XSlope (%)	8.1
N/A	Flare Type LT	N/A	N/A	Flare Type RT	N/A
N/A	Flare Slope LT (%)	N/A	N/A	Flare Slope RT (%)	N/A
N/A	Flare Traversable LT?	N/A	N/A	Flare Traversable RT?	N/A
N/A	Landing Length (in)	N/A	N/A	DWS Provided?	N/A
N/A	Landing Width (in)	N/A	N/A	DWS Contrast?	N/A
N/A	Landing Slope (%)	N/A	N/A	DWS Length (in)	N/A
N/A	Landing X Slope (%)	N/A	N/A	DWS Full Width?	N/A
N/A	Landing Curb? (Y/N)	N/A	N/A	DWS Offset (in)	N/A
N/A	Shared Landing?	N/A			
N/A	Gutter Ponding?	N/A	N/A	Gutter Slope (%)	N/A
N/A	Gutter Lip Ht (in)	N/A	N/A	Gutter X Slope (%)	N/A
N/A	Painted X Walk1?	No	N/A	Painted X Walk2?	N/A
	X Walk 1 Direction	To SE		X Walk 2 Direction	N/A
N/A	X Walk 1 Width (in)	N/A	N/A	X Walk 2 Width (in)	N/A
	X Walk 1 Slope (%)	3.4		X Walk 2 Slope (%)	N/A
	X Walk 1 X Slope (%)	4.1		X Walk 2 X Slope (%)	N/A

Remove & Replace Entire Ramp.
