# Access Compliance Report

## Public Rights-of-Way

### (Curb Ramps)

Intersection ID: 42468	Main Street: MARVIN_RD	Cross Street: KINGSLEY_VIEW_DR	Location: SW
ADA ID: 72CAD6CFE166	Ramp Type: Perp	Initial Pass/Fail: Fail	Overall Compliance: No
Codes/Mitigation Info/Possible Solution		Field Measurements/Component Compliance	
Severity Score: 21.25

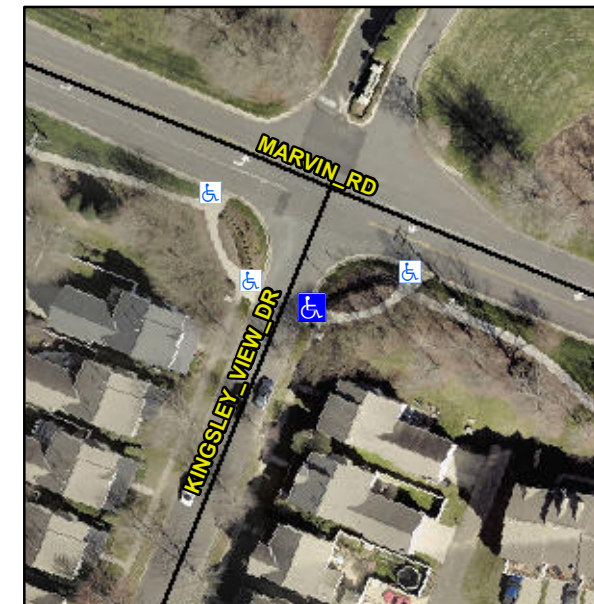
**Not Found, R304.5.1, R304.2.2**

Compliance	Description	Data	Compliance	Description	Data
N/A	Ramp Length (in)	95.0	No	Ramp Slope (%)	11.9
No	Ramp Width (in)	47.0	Yes	Ramp XSlope (%)	0.3
N/A	Flare Type LT	N/A	N/A	Flare Type RT	N/A
N/A	Flare Slope LT (%)	N/A	N/A	Flare Slope RT (%)	N/A
N/A	Flare Traversable LT?	N/A	N/A	Flare Traversable RT?	N/A
N/A	Landing Length (in)	N/A	N/A	DWS Provided?	N/A
N/A	Landing Width (in)	N/A	N/A	DWS Contrast?	N/A
N/A	Landing Slope (%)	N/A	N/A	DWS Length (in)	N/A
N/A	Landing X Slope (%)	N/A	N/A	DWS Full Width?	N/A
N/A	Landing Curb? (Y/N)	N/A	N/A	DWS Offset (in)	N/A
N/A	Shared Landing?	N/A			
N/A	Gutter Ponding?	N/A	N/A	Gutter Slope (%)	N/A
N/A	Gutter Lip Ht (in)	N/A	N/A	Gutter X Slope (%)	N/A
N/A	Painted X Walk1?	No	N/A	Painted X Walk2?	N/A
	X Walk 1 Direction	To NW		X Walk 2 Direction	N/A
N/A	X Walk 1 Width (in)	N/A	N/A	X Walk 2 Width (in)	N/A
	X Walk 1 Slope (%)	1.8		X Walk 2 Slope (%)	N/A
	X Walk 1 X Slope (%)	1.3		X Walk 2 X Slope (%)	N/A

N/A	Ramp inside XWalk1?	N/A	N/A	Ramp inside XWalk2?	N/A
	Road Slope (%)	N/A	N/A	Clear Space?	N/A
	Road X Slope (%)	N/A	N/A	Clear Space to XWalk (in)	N/A
N/A	Any Obstructions?	N/A	N/A	Storm Grate/Utility Hazard?	N/A
	Obstruction Type			Storm Grate/Utility Type	
		N/A			N/A
			Yes	Surface Condition? (G/P)	Good

Possible Solutions:

**Remove & Replace Entire Ramp.**
