Access Compliance Report Public Rights-of-Way (Curb Ramps)

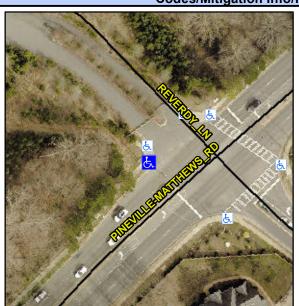
Intersection ID: 23868 Main Street: PINEVILLE-MATTHEWS RD **Cross Street: REVERDY LN** Location: W **Overall Compliance: No Severity Score:** 35 **ADA ID: 72CBAC765C44** Ramp Type: Perp Initial Pass/Fail: Fail

Compliance Description Data Compliance Description Data No N/A Ramp Length (in) 52.0 Ramp Slope (%) 13.3 No Ramp XSlope (%) No Ramp Width (in) 46.0 2.7 N/A N/A Flare Type LT N/A Flare Type RT N/A N/A N/A N/A Flare Slope RT (%) N/A Flare Slope LT (%) N/A Flare Traversable LT? N/A N/A Flare Traversable RT? N/A N/A N/A N/A **DWS Provided?** N/A Landing Length (in) N/A Landing Width (in) N/A N/A **DWS Contrast?** N/A N/A N/A N/A Landing Slope (%) DWS Length (in) N/A Landing X Slope (%) N/A N/A DWS Full Width? N/A Landing Curb? (Y/N) N/A N/A DWS Offset (in) N/A N/A Shared Landing? **Gutter Ponding?** N/A N/A Gutter Slope (%) N/A Gutter Lip Ht (in) 1.5 N/A Gutter X Slope (%) N/A Painted X Walk1? No N/A Painted X Walk2? N/A X Walk 1 Direction To SE X Walk 2 Direction N/A N/A N/A X Walk 1 Width (in) X Walk 2 Width (in) N/A X Walk 1 Slope (%) 2.7 X Walk 2 Slope (%) N/A X Walk 1 X Slope (%) 1.2 X Walk 2 X Slope (%) N/A N/A N/A Ramp inside XWalk2? Ramp inside XWalk1? N/A Road Slope (%) N/A N/A Clear Space? N/A N/A Road X Slope (%) N/A Clear Space to XWalk (in) N/A N/A Any Obstructions? N/A Storm Grate/Utility Hazard? N/A **Obstruction Type** Storm Grate/Utility Type N/A N/A Yes Surface Condition? (G/P) Good

Street 1 Name PINEVILLE-MATTHEWS RD Stop Condition-Street 2 Signal N/A Street 2 Name Stop Condition-Street 1 N/A Possible Solutions: Remove & Replace Entire Ramp. Surveyor Notes: N/A PROW/ADA: R304.5.1, R304.2.2, R304.5.3

N/A N/A N/A N/A N/A N/A N/A N/A N/A Total Cost: 1850.00
