Access Compliance Report

Public Rights-of-Way

(Curb Ramps)

Intersection ID: 10034711	Main Street: POINDEXTER_DR	Cross Street: N/A	Location: S
ADA ID: 72CFFA872117	Ramp Type: BlendTrans1	Initial Pass/Fail: Fail	Overall Compliance: No
		Severity Score: 25

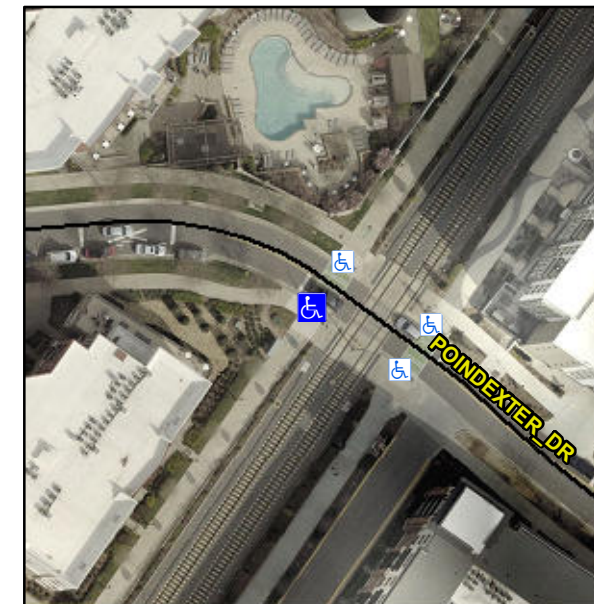
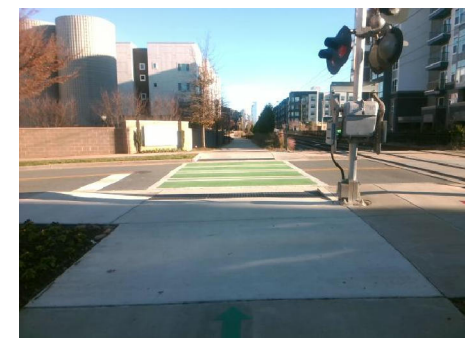
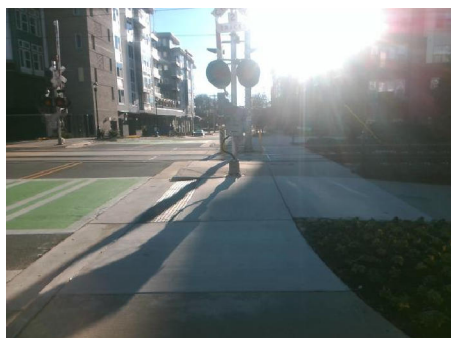
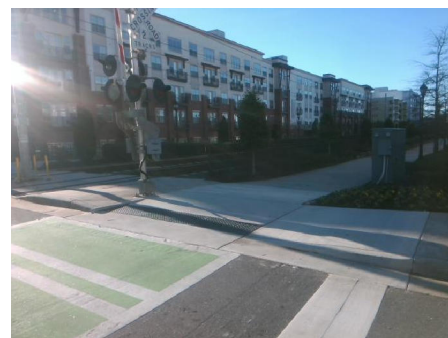
Compliance	Description	Data	Compliance	Description	Data
N/A	Ramp Length (in)	96.0	Yes	BlendTrans Slope (%)	3.6
Yes	Ramp Width (in)	143.0	No	BlendTrans XSlope (%)	9.7
N/A	Flare Type LT	N/A	N/A	Flare Type RT	N/A
N/A	Flare Slope LT (%)	N/A	N/A	Flare Slope RT (%)	N/A
N/A	Flare Traversable LT?	N/A	N/A	Flare Traversable RT?	N/A
N/A	Landing Length (in)	N/A	N/A	DWS Provided?	N/A
N/A	Landing Width (in)	N/A	N/A	DWS Contrast?	N/A
N/A	Landing Slope (%)	N/A	N/A	DWS Length (in)	N/A
N/A	Landing X Slope (%)	N/A	N/A	DWS Full Width?	N/A
N/A	Landing Curb? (Y/N)	N/A	N/A	DWS Offset (in)	N/A
N/A	Shared Landing?	N/A			
N/A	Gutter Ponding?	N/A	N/A	Gutter Slope (%)	N/A
N/A	Gutter Lip Ht (in)	N/A	N/A	Gutter X Slope (%)	N/A
N/A	Painted X Walk1?	Yes	N/A	Painted X Walk2?	N/A
	X Walk 1 Direction	To NE		X Walk 2 Direction	N/A
	X Walk 1 Width (in)	160.0		X Walk 2 Width (in)	N/A
	X Walk 1 Slope (%)	0.2		X Walk 2 Slope (%)	N/A
	X Walk 1 X Slope (%)	2.1		X Walk 2 X Slope (%)	N/A

N/A	Ramp inside XWalk1?	Yes	N/A	Ramp inside XWalk2?	N/A
	Road Slope (%)	2.1		Clear Space?	N/A
	Road X Slope (%)	0.2	N/A	Clear Space to XWalk (in)	N/A
N/A	Any Obstructions?	N/A	N/A	Storm Grate/Utility Hazard?	N/A
	Obstruction Type			Storm Grate/Utility Type	
		N/A			N/A
			Yes	Surface Condition? (G/P)	Good
			N/A	Curb Slope (%)	3.8

Remove & Replace Curb Ramp With Two New Directional Ramps or Equivalent.
