Access Compliance Report

Public Rights-of-Way

(Curb Ramps)

Intersection ID: 30042	Main Street: FOREST_CROSS_DR	Cross Street: WATERS_TRAIL_DR	Location: SE
ADA ID: 72D046A6A84F	Ramp Type: Combination1Diag	Initial Pass/Fail: Fail	Overall Compliance: No
		Severity Score: 0

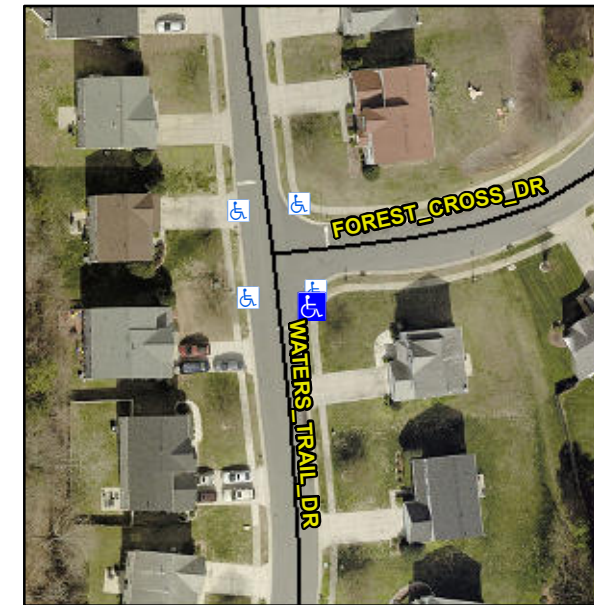
LT RP < 5%

Not Found, R304.5.1, R304.5.3

Compliance	Description	Data	Compliance	Description	Data
N/A	Ramp Length LT (in)	36.0	N/A	Ramp Length RT (in)	37.5
No	Ramp Width LT (in)	47.0	No	Ramp Width RT (in)	47.0
Yes	Ramp Slope LT (%)	1.9	Yes	Ramp Slope RT (%)	5.7
No	Ramp XSlope LT (%)	3.5	Yes	Ramp XSlope RT (%)	1.9
N/A	Ramp Length (in)	46.5	Yes	Ramp Slope (%)	7.0
Yes	Ramp Width (in)	49.0	No	Ramp XSlope (%)	2.4
N/A	Flare Type LT	N/A	N/A	Flare Type RT	N/A
N/A	Flare Slope LT (%)	N/A	N/A	Flare Slope RT (%)	N/A
N/A	Flare Traversable LT?	N/A	N/A	Flare Traversable RT?	N/A
N/A	Landing Length (in)	N/A	N/A	DWS Provided?	N/A
N/A	Landing Width (in)	N/A	N/A	DWS Contrast?	N/A
N/A	Landing Slope (%)	N/A	N/A	DWS Length (in)	N/A
N/A	Landing X Slope (%)	N/A	N/A	DWS Full Width?	N/A
N/A	Landing Curb? (Y/N)	N/A	N/A	DWS Offset (in)	N/A
N/A	Shared Landing?	N/A			
N/A	Gutter Ponding?	N/A	N/A	Gutter Slope (%)	N/A
N/A	Gutter Lip Ht (in)	N/A	N/A	Gutter X Slope (%)	N/A
N/A	Painted X Walk1?	No	N/A	Painted X Walk2?	No

X Walk 1 Direction	To N		X Walk 2 Direction	To W
	X Walk 1 Width (in)	N/A		X Walk 2 Width (in)	N/A
	X Walk 1 Slope (%)	3.3		X Walk 2 Slope (%)	0.4
	X Walk 1 X Slope (%)	1.9		X Walk 2 X Slope (%)	4.8
N/A	Ramp inside XWalk1?	N/A	N/A	Ramp inside XWalk2?	N/A
	Road Slope (%)	3.1		Clear Space?	N/A
	Road X Slope (%)	0.3	N/A	Clear Space to XWalk (in)	N/A
			N/A	Any Obstruction?	N/A
				Obstruction Type	N/A
			N/A	Storm Grate/Utility Hazard?	N/A
				Storm Grate/Utility Type	N/A
Yes	Surface Condition? (G/P)	Good			
	Curb Slope (%)	13.2

Remove & Replace Curb Ramp With Two New Directional Ramps or Equivalent.
