# Access Compliance Report

## Public Rights-of-Way

### (Curb Ramps)

Intersection ID: N/A	Main Street: E 4TH ST	Cross Street: N/A	Location: N
ADA ID: 72D15438B043	Ramp Type: PerpDiag	Initial Pass/Fail: Fail	Overall Compliance: No
Severity Score: 22.5			
Codes/Mitigation Info/Possible Solution		Field Measurements/Component Compliance

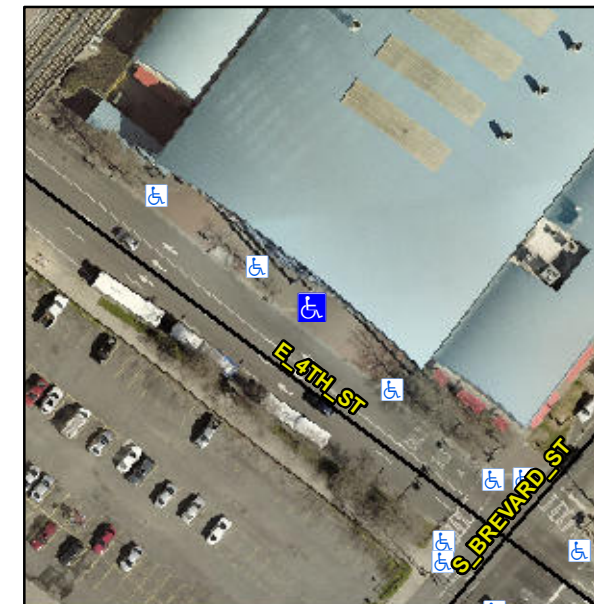
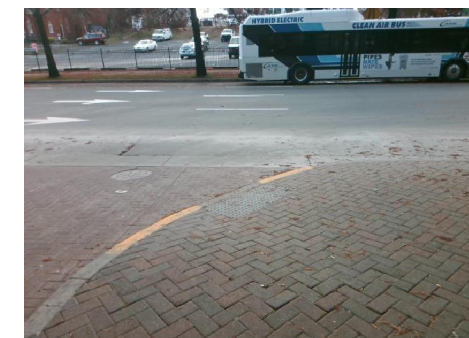
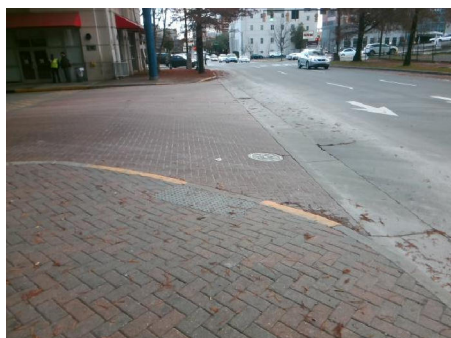
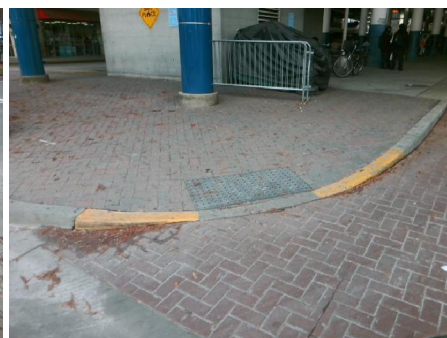
**Not Found, R304.5.1, R304.2.2**

Compliance	Description	Data	Compliance	Description	Data
N/A	Ramp Length (in)	70.0	No	Ramp Slope (%)	8.9
No	Ramp Width (in)	46.0	Yes	Ramp XSlope (%)	3.3
N/A	Flare Type LT	N/A	N/A	Flare Type RT	N/A
N/A	Flare Slope LT (%)	N/A	N/A	Flare Slope RT (%)	N/A
N/A	Flare Traversable LT?	No	N/A	Flare Traversable RT?	No
N/A	Landing Length (in)	N/A	N/A	DWS Provided?	N/A
N/A	Landing Width (in)	N/A	N/A	DWS Contrast?	N/A
N/A	Landing Slope (%)	N/A	N/A	DWS Length (in)	N/A
N/A	Landing X Slope (%)	N/A	N/A	DWS Full Width?	N/A
N/A	Landing Curb? (Y/N)	N/A	N/A	DWS Offset (in)	N/A
N/A	Shared Landing?	N/A			
N/A	Gutter Ponding?	N/A	N/A	Gutter Slope (%)	N/A
N/A	Gutter Lip Ht (in)	N/A	N/A	Gutter X Slope (%)	N/A
N/A	Painted X Walk1?	No	N/A	Painted X Walk2?	No
	X Walk 1 Direction	To SW		X Walk 2 Direction	To SE
N/A	X Walk 1 Width (in)	N/A	N/A	X Walk 2 Width (in)	N/A
	X Walk 1 Slope (%)	7.9		X Walk 2 Slope (%)	2.2
	X Walk 1 X Slope (%)	0.9		X Walk 2 X Slope (%)	7.3

N/A	Ramp inside XWalk1?	N/A	N/A	Ramp inside XWalk2?	N/A
	Road Slope (%)	4.9	N/A	Clear Space?	N/A
	Road X Slope (%)	5.9	N/A	Clear Space to XWalk (in)	N/A
N/A	Any Obstructions?	N/A	N/A	Storm Grate/Utility Hazard?	N/A
	Obstruction Type			Storm Grate/Utility Type	
		N/A			N/A
			Yes	Surface Condition? (G/P)	Good

**Remove & Replace Curb Ramp With Two New Directional Ramps or Equivalent.**
