Access Compliance Report

Public Rights-of-Way

(Curb Ramps)

Intersection ID: 11709	Main Street: W_7TH_ST	Cross Street: N_PINE_ST	Location: W
ADA ID: 72D73239F455	Ramp Type: PerpDiag	Initial Pass/Fail: Fail	Overall Compliance: No
Severity Score: 12.5			
Codes/Mitigation Info/Possible Solution		Field Measurements/Component Compliance

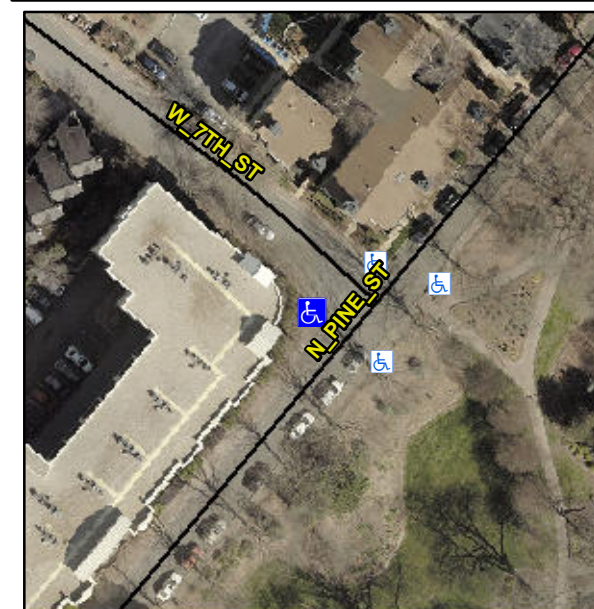
Compliance	Description	Data	Compliance	Description	Data
N/A	Ramp Length (in)	73.0	No	Ramp Slope (%)	8.7
Yes	Ramp Width (in)	48.0	Yes	Ramp XSlope (%)	1.2
N/A	Flare Type LT	N/A	N/A	Flare Type RT	N/A
N/A	Flare Slope LT (%)	N/A	N/A	Flare Slope RT (%)	N/A
N/A	Flare Traversable LT?	N/A	N/A	Flare Traversable RT?	N/A
N/A	Landing Length (in)	N/A	N/A	DWS Provided?	N/A
N/A	Landing Width (in)	N/A	N/A	DWS Contrast?	N/A
N/A	Landing Slope (%)	N/A	N/A	DWS Length (in)	N/A
N/A	Landing X Slope (%)	N/A	N/A	DWS Full Width?	N/A
N/A	Landing Curb? (Y/N)	N/A	N/A	DWS Offset (in)	N/A
N/A	Shared Landing?	N/A			
N/A	Gutter Ponding?	N/A	N/A	Gutter Slope (%)	N/A
N/A	Gutter Lip Ht (in)	N/A	N/A	Gutter X Slope (%)	N/A
N/A	Painted X Walk1?	No	N/A	Painted X Walk2?	No
	X Walk 1 Direction	To SE		X Walk 2 Direction	To NE
N/A	X Walk 1 Width (in)	N/A	N/A	X Walk 2 Width (in)	N/A
	X Walk 1 Slope (%)	3.1		X Walk 2 Slope (%)	2.6
	X Walk 1 X Slope (%)	2.4		X Walk 2 X Slope (%)	2.2

N/A	Ramp inside XWalk1?	N/A	N/A	Ramp inside XWalk2?	N/A
	Road Slope (%)	1.0	N/A	Clear Space?	N/A
	Road X Slope (%)	3.7	N/A	Clear Space to XWalk (in)	N/A
N/A	Any Obstructions?	N/A	N/A	Storm Grate/Utility Hazard?	N/A
	Obstruction Type			Storm Grate/Utility Type	
		N/A			N/A
			Yes	Surface Condition? (G/P)	Good

Remove & Replace Curb Ramp With Two New Directional Ramps or Equivalent.
