Access Compliance Report Public Rights-of-Way (Curb Ramps)

Intersection ID: 14910 **Main Street:** LYNDHURST_AV **Cross Street:** IVERSON_WY **Location:** N

ADA ID: 72D86459C92F **Ramp Type:** Perp **Initial Pass/Fail:** Fail **Overall Compliance:** No **Severity Score:** 12.5

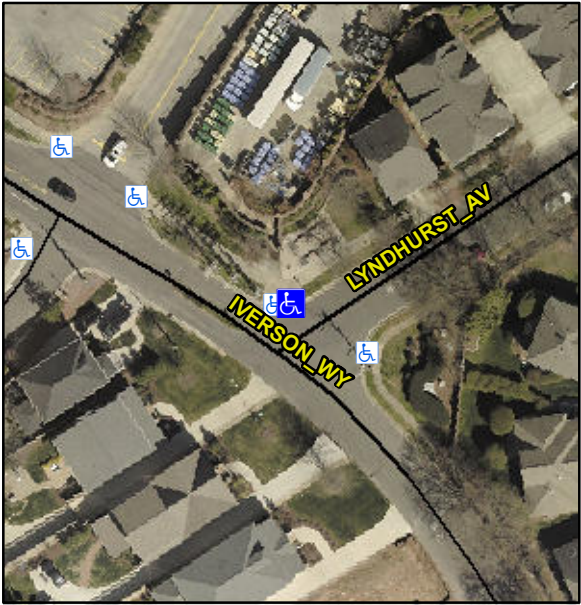
PROW/ADA:
R304.2.2

Compliance	Description	Data	Compliance	Description	Data
N/A	Ramp Length (in)	81.0	No	Ramp Slope (%)	9.1
Yes	Ramp Width (in)	49.0	Yes	Ramp XSlope (%)	1.4
N/A	Flare Type LT	N/A	N/A	Flare Type RT	N/A
N/A	Flare Slope LT (%)	N/A	N/A	Flare Slope RT (%)	N/A
N/A	Flare Traversable LT?	N/A	N/A	Flare Traversable RT?	N/A
N/A	Landing Length (in)	N/A	N/A	DWS Provided?	N/A
N/A	Landing Width (in)	N/A	N/A	DWS Contrast?	N/A
N/A	Landing Slope (%)	N/A	N/A	DWS Length (in)	N/A
N/A	Landing X Slope (%)	N/A	N/A	DWS Full Width?	N/A
N/A	Landing Curb? (Y/N)	N/A	N/A	DWS Offset (in)	N/A
N/A	Shared Landing?	N/A			
N/A	Gutter Ponding?	N/A	N/A	Gutter Slope (%)	N/A
N/A	Gutter Lip Ht (in)	N/A	N/A	Gutter X Slope (%)	N/A
N/A	Painted X Walk1?	No	N/A	Painted X Walk2?	N/A
	X Walk 1 Direction	To SE		X Walk 2 Direction	N/A
N/A	X Walk 1 Width (in)	N/A	N/A	X Walk 2 Width (in)	N/A
	X Walk 1 Slope (%)	2.3		X Walk 2 Slope (%)	N/A
	X Walk 1 X Slope (%)	0.7		X Walk 2 X Slope (%)	N/A

N/A	Ramp inside XWalk1?	N/A	N/A	Ramp inside XWalk2?	N/A
	Road Slope (%)	N/A	N/A	Clear Space?	N/A
	Road X Slope (%)	N/A	N/A	Clear Space to XWalk (in)	N/A
N/A	Any Obstructions?	N/A	N/A	Storm Grate/Utility Hazard?	N/A
	Obstruction Type			Storm Grate/Utility Type	
			N/A		N/A
			Yes	Surface Condition? (G/P)	Good

Possible Solutions:
Remove & Replace Entire Ramp.

Total Cost: \$ 1850.00
