# Access Compliance Report

## Public Rights-of-Way

### (Curb Ramps)

Intersection ID: 54218	Main Street: GOLF_LINKS_DR	Cross Street: SANDY_ROCK_PL	Location: NW
ADA ID: 72E424C70FE6	Ramp Type: Perp	Initial Pass/Fail: Fail	Overall Compliance: No
Severity Score: 12.5			
Codes/Mitigation Info/Possible Solution		Field Measurements/Component Compliance

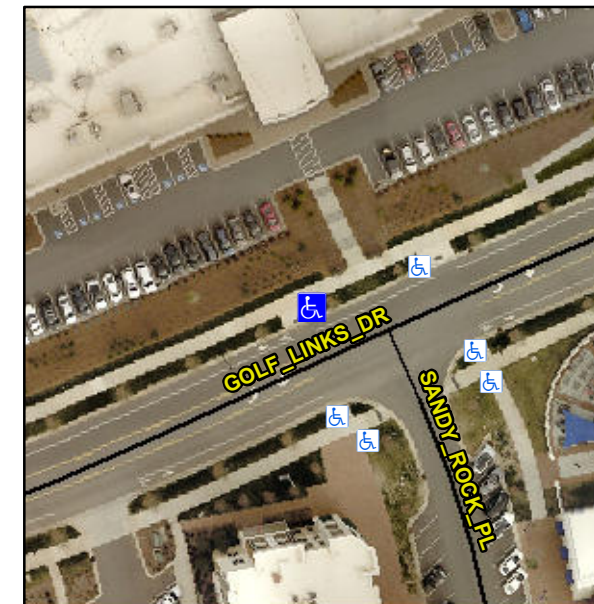
**Not Found, R304.2.2**

Compliance	Description	Data	Compliance	Description	Data
N/A	Ramp Length (in)	95.5	No	Ramp Slope (%)	9.1
Yes	Ramp Width (in)	60.0	Yes	Ramp XSlope (%)	1.7
N/A	Flare Type LT	N/A	N/A	Flare Type RT	N/A
N/A	Flare Slope LT (%)	N/A	N/A	Flare Slope RT (%)	N/A
N/A	Flare Traversable LT?	N/A	N/A	Flare Traversable RT?	N/A
N/A	Landing Length (in)	N/A	N/A	DWS Provided?	N/A
N/A	Landing Width (in)	N/A	N/A	DWS Contrast?	N/A
N/A	Landing Slope (%)	N/A	N/A	DWS Length (in)	N/A
N/A	Landing X Slope (%)	N/A	N/A	DWS Full Width?	N/A
N/A	Landing Curb? (Y/N)	N/A	N/A	DWS Offset (in)	N/A
N/A	Shared Landing?	N/A			
N/A	Gutter Ponding?	N/A	N/A	Gutter Slope (%)	N/A
N/A	Gutter Lip Ht (in)	N/A	N/A	Gutter X Slope (%)	N/A
N/A	Painted X Walk1?	No	N/A	Painted X Walk2?	N/A
	X Walk 1 Direction	To S		X Walk 2 Direction	N/A
N/A	X Walk 1 Width (in)	N/A	N/A	X Walk 2 Width (in)	N/A
	X Walk 1 Slope (%)	4.2		X Walk 2 Slope (%)	N/A
	X Walk 1 X Slope (%)	1.2		X Walk 2 X Slope (%)	N/A

**Remove & Replace Entire Ramp.**
