Access Compliance Report Public Rights-of-Way (Curb Ramps)

Intersection ID: 48602 Main Street: S_TRYON_ST Cross Street: GRANDIFLORA_DR Location: NW

ADA ID: 72EF6A05D99A Ramp Type: PerpDiag Initial Pass/Fail: Fail Overall Compliance: No Severity Score: 33.75

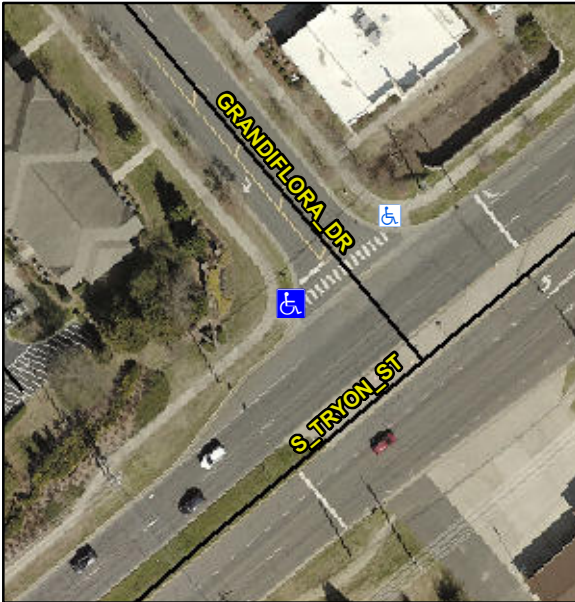
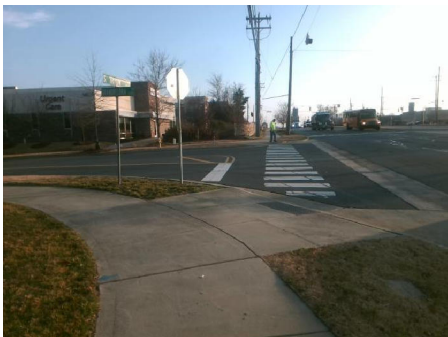
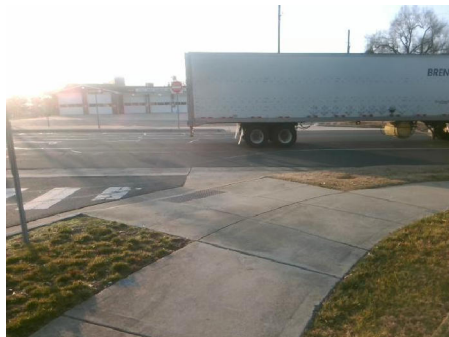
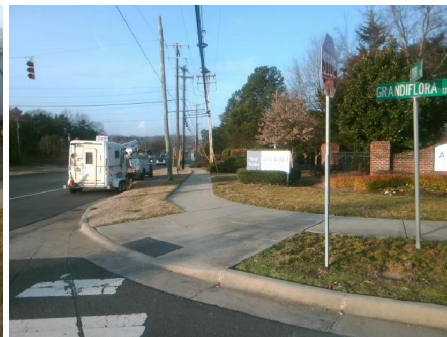
PROW/ADA:
Not Found, R304.5.1, R304.2.2, R304.5.3

| Compliance | Description | Data | Compliance | Description | Data |
|---|---|---|---|---|---|
| N/A | Ramp Length (in) | 95.0 | No | Ramp Slope (%) | 8.9 |
| No | Ramp Width (in) | 47.5 | No | Ramp XSlope (%) | 6.1 |

Possible Solutions:
Remove & Replace Curb Ramp With Two New Directional Ramps or Equivalent.
