# Access Compliance Report

## Public Rights-of-Way

### (Curb Ramps)

| Intersection ID: 11308 | Main Street: CARDIFF_AV | Cross Street: SPRINGWAY_DR | Location: NE |

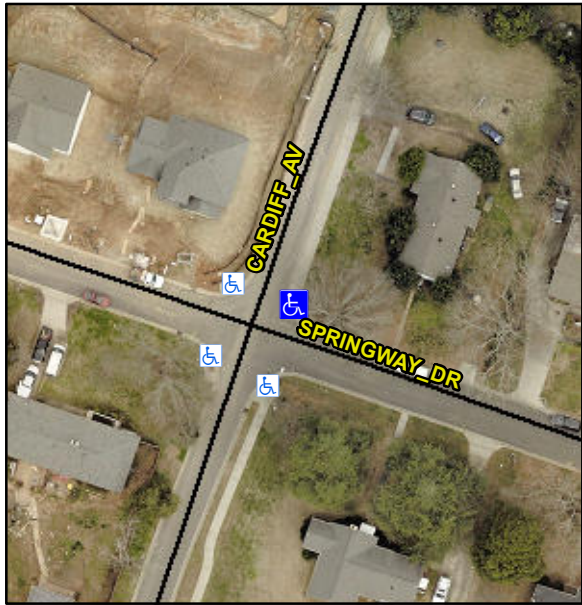
| ADA ID: 72EFC03071FC | Ramp Type: BlendTrans1 | Initial Pass/Fail: Fail | Overall Compliance: No |

| Codes/Mitigation Info/Possible Solution | | | Field Measurements/Component Compliance | | | | | |
|---|---|---|---|---|---|---|---|---|
| | | | No | Ramp Width (in) | 42.0 | Yes | BlendTrans XSlope (%) | 1.4 |
| Surveyor Notes:<br><br>N/A<br><br>PROW/ADA:<br><br>Not Found, R304.5.1 | | N/A | Landing Curb? (Y/N) | N/A | N/A | DWS Offset (in) | N/A | |
| | | No | | Curb Slope (%) | 15.6 | | | |

| Codes/Mitigation Info/Possible Solution | | | Field Measurements/Component Compliance | | | | | |
|---|---|---|---|---|---|---|---|---|
| | Remove & Replace Curb Ramp With Two New Directional Ramps or Equivalent. | | N/A | Ramp Length (in) | 71.0 | Yes | BlendTrans Slope (%) | 3.7 |
