Access Compliance Report

Public Rights-of-Way

(Curb Ramps)

Intersection ID: 18518	Main Street: MURRAYHILL_RD	Cross Street: WEDGEWOOD_DR	Location: NW
ADA ID: 72F068871537	Ramp Type: Directional1	Initial Pass/Fail: Fail	Overall Compliance: No
		Severity Score: 1.25

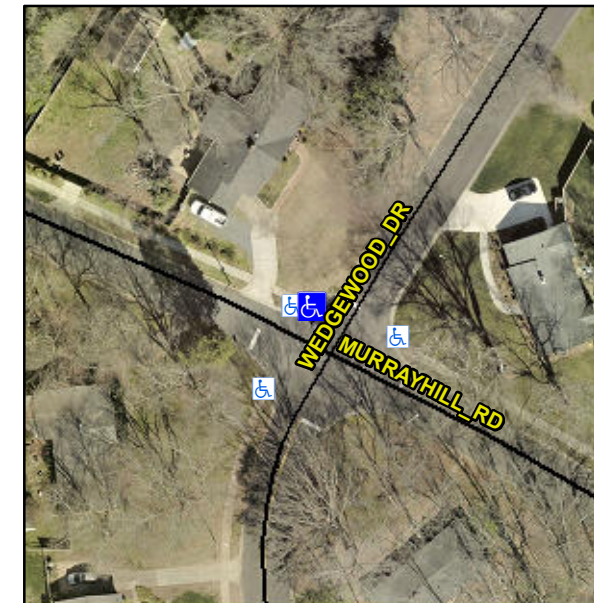
Compliance	Description	Data	Compliance	Description	Data
N/A	Ramp Length (in)	59.0	N/A	Grade Break?	N/A
Yes	Ramp Width (in)	57.0	N/A	Grade Break Slope (%)	0.0
Yes	Ramp Slope (%)	2.9	N/A	Grade Break XSlope (%)	0.0
No	Ramp XSlope (%)	2.2			
N/A	Flare Type LT	N/A	N/A	Flare Type RT	N/A
N/A	Flare Slope LT (%)	N/A	N/A	Flare Slope RT (%)	0.0
N/A	Flare Traversable LT?	N/A	N/A	Flare Traversable RT?	N/A
N/A	Landing Length (in)	0.0	N/A	DWS Provided?	N/A
N/A	Landing Width (in)	0.0	N/A	DWS Contrast?	N/A
N/A	Landing Slope (%)	0.0	N/A	DWS Length (in)	N/A
N/A	Landing X Slope (%)	0.0	N/A	DWS Full Width?	N/A
N/A	Landing Curb? (Y/N)	N/A	N/A	DWS Offset LT (in)	N/A
N/A	Shared Landing?	N/A	N/A	DWS Offset RT (in)	N/A
N/A	Gutter Ponding?	0.0	N/A	Gutter Slope (%)	N/A
N/A	Gutter Lip Ht (in)	0.0	N/A	Gutter X Slope (%)	N/A
N/A	Painted X Walk1?	No		Road Slope (%)	1.6
	X Walk 1 Direction	To E		Road X Slope (%)	5.1
	X Walk 1 Width (in)	N/A		Clear Space?	N/A

X Walk 1 Slope (%)	1.6	N/A	Clear Space to XWalk (in)	N/A
	X Walk 1 X Slope (%)	5.1	N/A	Storm Grate/Utility Hazard?	N/A
N/A	Ramp inside XWalk1?	N/A		Storm Grate/Utility Type	
N/A	Any Obstructions?	N/A			N/A
	Obstruction Type		Yes	Surface Condition? (G/P)	Good
			N/A	Curb Slope (%)	5.9

Possible Solutions:

Remove & Replace Entire Ramp.

R304.5.3
