# Access Compliance Report

## Public Rights-of-Way

| Intersection ID: 25474 | Main Street: MCMULLEN_CREEK_PY | Cross Street: JOHNSTON_RD | Location: SW |
| ADA ID: 72F15187CA3E | Ramp Type: PerpDiag | Initial Pass/Fail: Fail | Overall Compliance: No |

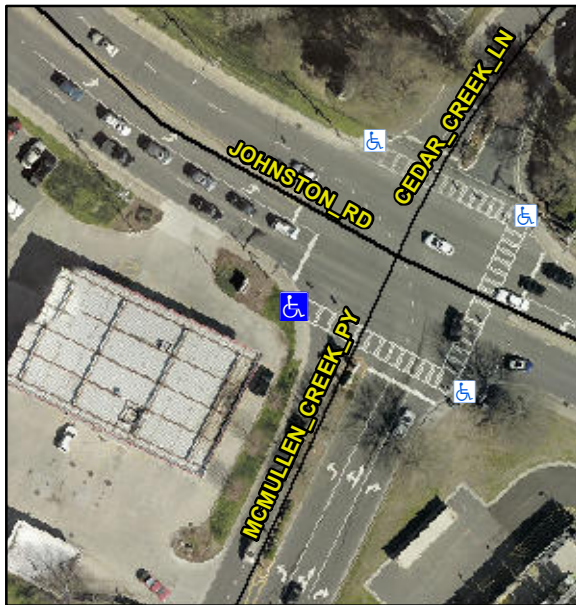
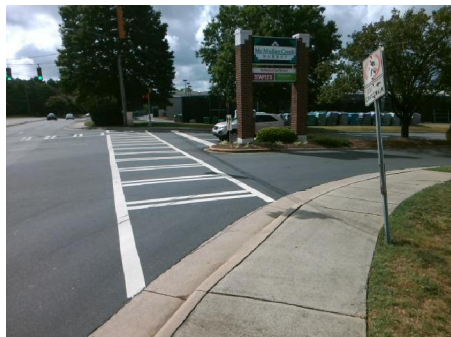
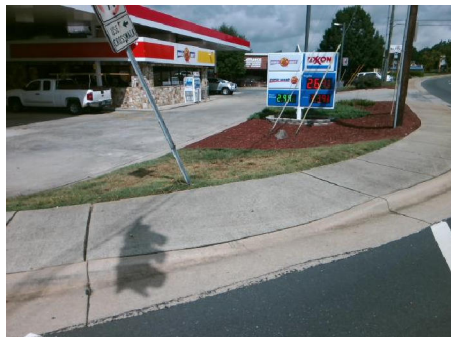
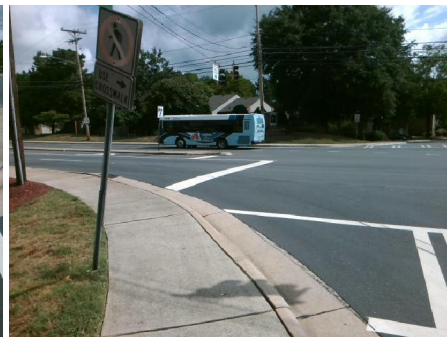
| | | Severity Score: 12.5 | |

**Not Found, R304.2.2**

| Compliance | Description | Data | Compliance | Description | Data |
|---|---|---|---|---|---|
| N/A | Ramp Length (in) | 59.0 | No | Ramp Slope (%) | 9.1 |

**Remove & Replace Curb Ramp With Two New Directional Ramps or Equivalent.**
