Access Compliance Report

Public Rights-of-Way

(Curb Ramps)

Intersection ID: 28094	Main Street: MITCHELL_GLEN_DR	Cross Street: SCOTTISH_KILT_CT	Location: SW
ADA ID: 72FF612F50EB	Ramp Type: BlendTrans1	Initial Pass/Fail: Fail	Overall Compliance: No
Severity Score: 21.25			
Codes/Mitigation Info/Possible Solution		Field Measurements/Component Compliance

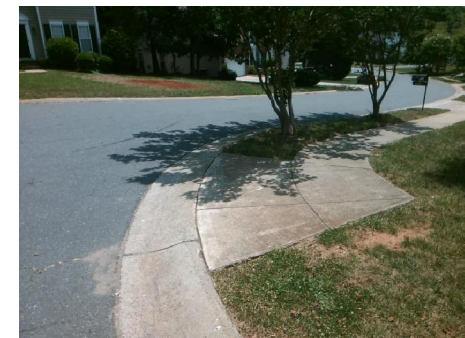
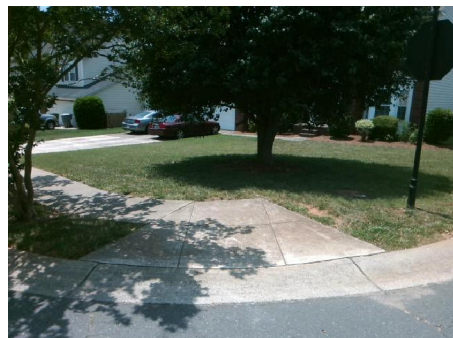
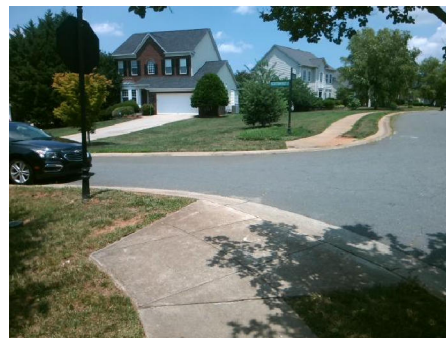
Compliance	Description	Data	Compliance	Description	Data
N/A	Ramp Length (in)	48.0	Yes	BlendTrans Slope (%)	2.3
No	Ramp Width (in)	47.5	No	BlendTrans XSlope (%)	5.2
N/A	Flare Type LT	N/A	N/A	Flare Type RT	N/A
N/A	Flare Slope LT (%)	N/A	N/A	Flare Slope RT (%)	N/A
N/A	Flare Traversable LT?	N/A	N/A	Flare Traversable RT?	N/A
N/A	Landing Length (in)	N/A	N/A	DWS Provided?	N/A
N/A	Landing Width (in)	N/A	N/A	DWS Contrast?	N/A
N/A	Landing Slope (%)	N/A	N/A	DWS Length (in)	N/A
N/A	Landing X Slope (%)	N/A	N/A	DWS Full Width?	N/A
N/A	Landing Curb? (Y/N)	N/A	N/A	DWS Offset (in)	N/A
N/A	Shared Landing?	N/A			
N/A	Gutter Ponding?	N/A	N/A	Gutter Slope (%)	N/A
N/A	Gutter Lip Ht (in)	N/A	N/A	Gutter X Slope (%)	N/A
N/A	Painted X Walk1?	No	N/A	Painted X Walk2?	No
	X Walk 1 Direction	To E		X Walk 2 Direction	To NW
	X Walk 1 Width (in)	N/A		X Walk 2 Width (in)	N/A
	X Walk 1 Slope (%)	3.1		X Walk 2 Slope (%)	4.5
	X Walk 1 X Slope (%)	5.8		X Walk 2 X Slope (%)	0.8

N/A	Ramp inside XWalk1?	N/A	N/A	Ramp inside XWalk2?	N/A
	Road Slope (%)	3.6		Clear Space?	N/A
	Road X Slope (%)	7.5	N/A	Clear Space to XWalk (in)	N/A
N/A	Any Obstructions?	N/A	N/A	Storm Grate/Utility Hazard?	N/A
	Obstruction Type			Storm Grate/Utility Type	
		N/A			N/A
			Yes	Surface Condition? (G/P)	Good
			N/A	Curb Slope (%)	3.7

Remove & Replace Curb Ramp With Two New Directional Ramps or Equivalent.
