Access Compliance Report Public Rights-of-Way (Curb Ramps)

Intersection ID: 10023798 Main Street: COLONY_RD Cross Street: FAIRINGTON_APARTMENTS_DR Location: SE

ADA ID: 72FFA9D6A9AA Ramp Type: Directional1 Initial Pass/Fail: Fail Overall Compliance: No Severity Score: 1.25

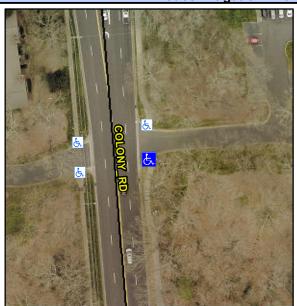
Possible Solution		Field Measurements/Component Compilance					
Possible Solutions:		Compliance Description		Data	Data Compliance Description		Data
Remove & Replace Entire F	Ramp.	N/A	Ramp Length (in)	84.0	N/A	Grade Break?	N/A

•	•	Yes	Ramp Width (in)	71.0	N/A	Grade Break Slope (%)	0.0
		Yes	Ramp Slope (%)	5.0	N/A	Grade Break XSlope (%)	0.0
		No	Ramp XSlope (%)	3.2			
		N/A	Flare Type LT	N/A	N/A	Flare Type RT	N/A
		N/A	Flare Slope LT (%)	N/A	N/A	Flare Slope RT (%)	0.0
Surveyor Notes:		N/A	Flare Traversable LT?	N/A	N/A	Flare Traversable RT?	N/A
N/A		N/A	Landing Length (in)	0.0	N/A	DWS Provided?	N/A
		N/A	Landing Width (in)	0.0	N/A	DWS Contrast?	N/A
		N/A	Landing Slope (%)	0.0	N/A	DWS Length (in)	N/A
		N/A	Landing X Slope (%)	0.0	N/A	DWS Full Width?	N/A
PROW/ADA:		N/A	Landing Curb? (Y/N)	N/A	N/A	DWS Offset LT (in)	N/A
R304.5.3		N/A	Shared Landing?	N/A	N/A	DWS Offset RT (in)	N/A
		N/A	Gutter Ponding?	0.0	N/A	Gutter Slope (%)	N/A
		N/A	Gutter Lip Ht (in)	0.0	N/A	Gutter X Slope (%)	N/A
		N/A	Painted X Walk1?	No		Road Slope (%)	4.6
			X Walk 1 Direction	To N		Road X Slope (%)	2.0
			X Walk 1 Width (in)	N/A		Clear Space?	N/A
			X Walk 1 Slope (%)	4.6	N/A	Clear Space to XWalk (in)	N/A

X Walk 1 X Slope (%)	2.0	N/A	Storm Grate/Utility Hazard?	N/A
		N/A	Ramp inside XWalk1?	N/A		Storm Grate/Utility Type	
		N/A	Any Obstructions?	N/A			N/A
Total Cost:	\$ 1600.00		Obstruction Type		Yes	Surface Condition? (G/P)	Good
				N/A	N/A	Curb Slope (%)	2.1
