# Access Compliance Report

## Public Rights-of-Way

### (Curb Ramps)

| Intersection ID: 31282 | Main Street: MALLARD_GLEN_DR | Cross Street: TIGER_LN | Location: NE |

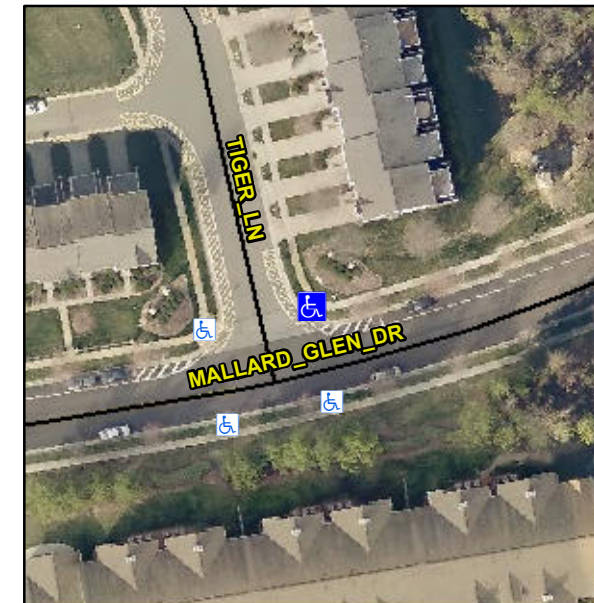
| ADA ID: 7301D88B5FC5 | Ramp Type: PerpDiag | Initial Pass/Fail: Fail | Overall Compliance: No |
| | | Severity Score: 60 | |

| Compliance | Description | Data | Compliance | Description | Data |
|---|---|---|---|---|---|
| N/A | Ramp Length (in) | 108.0 | No | Ramp Slope (%) | 13.6 |
| No | Ramp Width (in) | 28.0 | Yes | Ramp XSlope (%) | 0.5 |

**Remove & Replace Curb Ramp With Two New Directional Ramps or Equivalent.**

**R304.5.1, R304.2.2**
