Intersection ID: 21831	Main Street: ENGLAND_ST	Cross Street: WINDSOR_OAK_CT	Location:	NE
ADA ID: 730478885A25	Ramp Type: PerpDiag	Initial Pass/Fail: Fail	Overall Compliance: No	Severity Score: 37.5

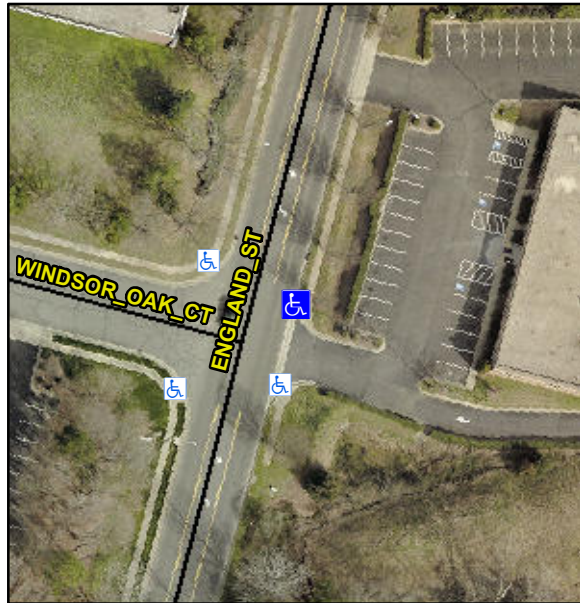
Not Found, R304.2.2, R304.5.3

Compliance	Description	Data	Compliance	Description	Data
N/A	Ramp Length (in)	59.0	No	Ramp Slope (%)	10.1
Yes	Ramp Width (in)	48.0	No	Ramp XSlope (%)	7.4
N/A	Flare Type LT	N/A	N/A	Flare Type RT	N/A
N/A	Flare Slope LT (%)	N/A	N/A	Flare Slope RT (%)	N/A
N/A	Flare Traversable LT?	N/A	N/A	Flare Traversable RT?	N/A
N/A	Landing Length (in)	N/A	N/A	DWS Provided?	N/A
N/A	Landing Width (in)	N/A	N/A	DWS Contrast?	N/A
N/A	Landing Slope (%)	N/A	N/A	DWS Length (in)	N/A
N/A	Landing X Slope (%)	N/A	N/A	DWS Full Width?	N/A
N/A	Landing Curb? (Y/N)	N/A	N/A	DWS Offset (in)	N/A
N/A	Shared Landing?	N/A			
N/A	Gutter Ponding?	N/A	N/A	Gutter Slope (%)	N/A
N/A	Gutter Lip Ht (in)	N/A	N/A	Gutter X Slope (%)	N/A
N/A	Painted X Walk1?	No	N/A	Painted X Walk2?	No
	X Walk 1 Direction	To NW		X Walk 2 Direction	To SW
N/A	X Walk 1 Width (in)	N/A	N/A	X Walk 2 Width (in)	N/A
	X Walk 1 Slope (%)	4.2		X Walk 2 Slope (%)	3.0
	X Walk 1 X Slope (%)	3.2		X Walk 2 X Slope (%)	13.5

N/A	Ramp inside XWalk1?	N/A	N/A	Ramp inside XWalk2?	N/A
	Road Slope (%)	6.3	N/A	Clear Space?	N/A
	Road X Slope (%)	11.6	N/A	Clear Space to XWalk (in)	N/A
N/A	Any Obstructions?	N/A	N/A	Storm Grate/Utility Hazard?	N/A
	Obstruction Type			Storm Grate/Utility Type	
		N/A			N/A
			Yes	Surface Condition? (G/P)	Good

Remove & Replace Curb Ramp With Two New Directional Ramps or Equivalent.
