Access Compliance Report

Public Rights-of-Way

(Curb Ramps)

Intersection ID: 49932	Main Street: WOBURN_RD	Cross Street: PAXTON_RUN_RD	Location: SW
ADA ID: 7305D98A0B3A	Ramp Type: Perp	Initial Pass/Fail: Fail	Overall Compliance: No
Severity Score: 25			
Codes/Mitigation Info/Possible Solution		Field Measurements/Component Compliance

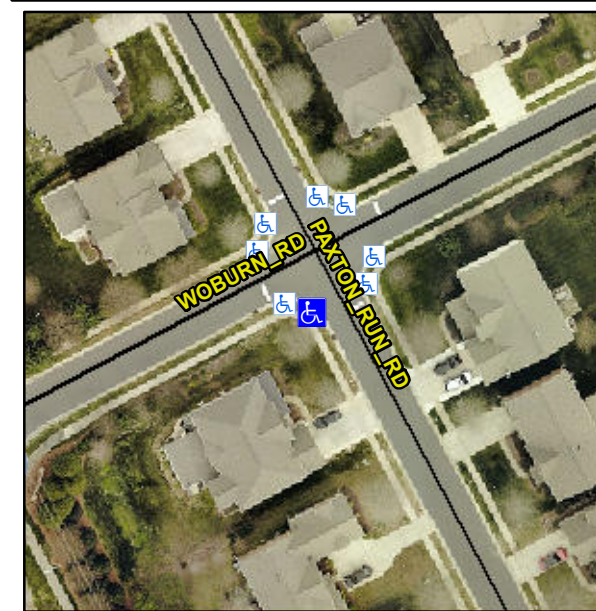
Not Found, R304.2.2, R304.5.3

Compliance	Description	Data	Compliance	Description	Data
N/A	Ramp Length (in)	47.0	No	Ramp Slope (%)	10.2
Yes	Ramp Width (in)	48.0	No	Ramp XSlope (%)	5.9
N/A	Flare Type LT	N/A	N/A	Flare Type RT	N/A
N/A	Flare Slope LT (%)	N/A	N/A	Flare Slope RT (%)	N/A
N/A	Flare Traversable LT?	N/A	N/A	Flare Traversable RT?	N/A
N/A	Landing Length (in)	N/A	N/A	DWS Provided?	N/A
N/A	Landing Width (in)	N/A	N/A	DWS Contrast?	N/A
N/A	Landing Slope (%)	N/A	N/A	DWS Length (in)	N/A
N/A	Landing X Slope (%)	N/A	N/A	DWS Full Width?	N/A
N/A	Landing Curb? (Y/N)	N/A	N/A	DWS Offset (in)	N/A
N/A	Shared Landing?	N/A			
N/A	Gutter Ponding?	N/A	N/A	Gutter Slope (%)	N/A
N/A	Gutter Lip Ht (in)	N/A	N/A	Gutter X Slope (%)	N/A
N/A	Painted X Walk1?	No	N/A	Painted X Walk2?	N/A
	X Walk 1 Direction	To NE		X Walk 2 Direction	N/A
N/A	X Walk 1 Width (in)	N/A	N/A	X Walk 2 Width (in)	N/A
	X Walk 1 Slope (%)	1.4		X Walk 2 Slope (%)	N/A
	X Walk 1 X Slope (%)	3.4		X Walk 2 X Slope (%)	N/A

N/A	Ramp inside XWalk1?	N/A	N/A	Ramp inside XWalk2?	N/A
	Road Slope (%)	N/A	N/A	Clear Space?	N/A
	Road X Slope (%)	N/A	N/A	Clear Space to XWalk (in)	N/A
N/A	Any Obstructions?	N/A	N/A	Storm Grate/Utility Hazard?	N/A
	Obstruction Type			Storm Grate/Utility Type	
		N/A			N/A
			Yes	Surface Condition? (G/P)	Good

Possible Solutions:

Remove & Replace Entire Ramp.
