# Access Compliance Report

## Public Rights-of-Way (Curb Ramps)

| Intersection ID: 48555 | Main Street: COTTON_PRESS_RD | Cross Street: RIDGEFOREST_DR | Location: SE |
| ADA ID: 73116F05CBF5 | Ramp Type: PerpDiag | Initial Pass/Fail: Pass | Overall Compliance: No |

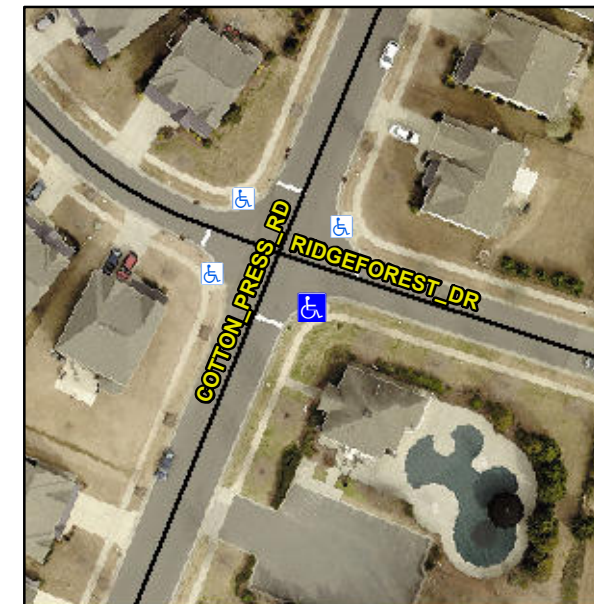
**Not Found, R304.2.1, R304.2.2-Perp, R304.3.2-Para, R304.5.3**

| Compliance | Description | Data | Compliance | Description | Data |
|---|---|---|---|---|---|
| No | Landing Width (in) | 47.0 | Yes | DWS Contrast? | Yes |
| No | Landing Slope (%) | 2.3 | Yes | DWS Length (in) | 24.0 |
| Yes | Gutter Lip Ht (in) | 0.0 | No | Gutter X Slope (%) | 3.3 |

**Remove & Replace Curb Ramp With Two New Directional Ramps or Equivalent. Remove & Replace Gutter.**
