# Access Compliance Report

## Public Rights-of-Way

### (Curb Ramps)

Intersection ID: 13347	Main Street: MCCLINTOCK_RD	Cross Street: NANDINA_ST	Location:	E
ADA ID: 731289F67B47	Ramp Type: Perp	Initial Pass/Fail: Fail	Overall Compliance: No	Severity Score: 1.25
Codes/Mitigation Info/Possible Solution		Field Measurements/Component Compliance

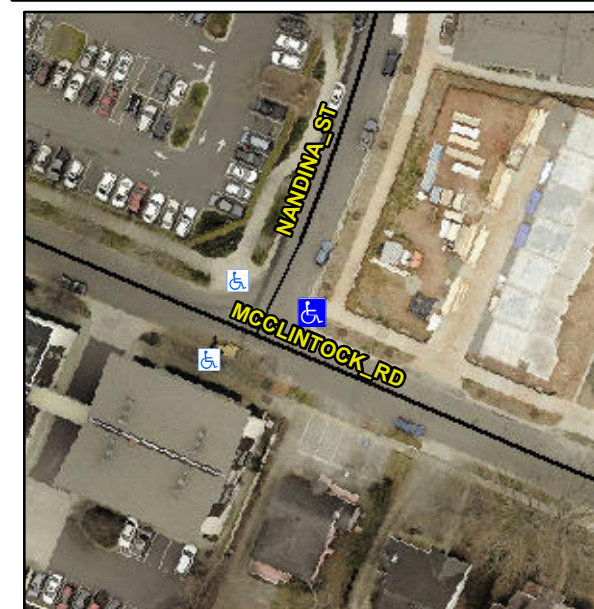
Compliance	Description	Data	Compliance	Description	Data
N/A	Ramp Length (in)	48.0	Yes	Ramp Slope (%)	7.5
Yes	Ramp Width (in)	48.0	No	Ramp XSlope (%)	2.3
N/A	Flare Type LT	N/A	N/A	Flare Type RT	N/A
N/A	Flare Slope LT (%)	N/A	N/A	Flare Slope RT (%)	N/A
N/A	Flare Traversable LT?	N/A	N/A	Flare Traversable RT?	N/A
N/A	Landing Length (in)	N/A	N/A	DWS Provided?	N/A
N/A	Landing Width (in)	N/A	N/A	DWS Contrast?	N/A
N/A	Landing Slope (%)	N/A	N/A	DWS Length (in)	N/A
N/A	Landing X Slope (%)	N/A	N/A	DWS Full Width?	N/A
N/A	Landing Curb? (Y/N)	N/A	N/A	DWS Offset (in)	N/A
N/A	Shared Landing?	N/A			
N/A	Gutter Ponding?	N/A	N/A	Gutter Slope (%)	N/A
N/A	Gutter Lip Ht (in)	1.0	N/A	Gutter X Slope (%)	N/A
N/A	Painted X Walk1?	No	N/A	Painted X Walk2?	N/A
	X Walk 1 Direction	To NW		X Walk 2 Direction	N/A
N/A	X Walk 1 Width (in)	N/A	N/A	X Walk 2 Width (in)	N/A
	X Walk 1 Slope (%)	0.8		X Walk 2 Slope (%)	N/A
	X Walk 1 X Slope (%)	0.3		X Walk 2 X Slope (%)	N/A

N/A	Ramp inside XWalk1?	N/A	N/A	Ramp inside XWalk2?	N/A
	Road Slope (%)	N/A	N/A	Clear Space?	N/A
	Road X Slope (%)	N/A	N/A	Clear Space to XWalk (in)	N/A
N/A	Any Obstructions?	N/A	N/A	Storm Grate/Utility Hazard?	N/A
	Obstruction Type			Storm Grate/Utility Type	
		N/A			N/A
			Yes	Surface Condition? (G/P)	Good

Possible Solutions:

**Remove & Replace Entire Ramp.**

**R304.5.3**

**\$ 1850.00**
