Access Compliance Report

Public Rights-of-Way

(Curb Ramps)

Intersection ID: 44470	Main Street: COREY_COMMON_AV	Cross Street: NEWFIELD_ST	Location: E
ADA ID: 73182BFBF69D	Ramp Type: BlendTrans1	Initial Pass/Fail: Fail	Overall Compliance: No
Severity Score: 8.75			
Codes/Mitigation Info/Possible Solution		Field Measurements/Component Compliance

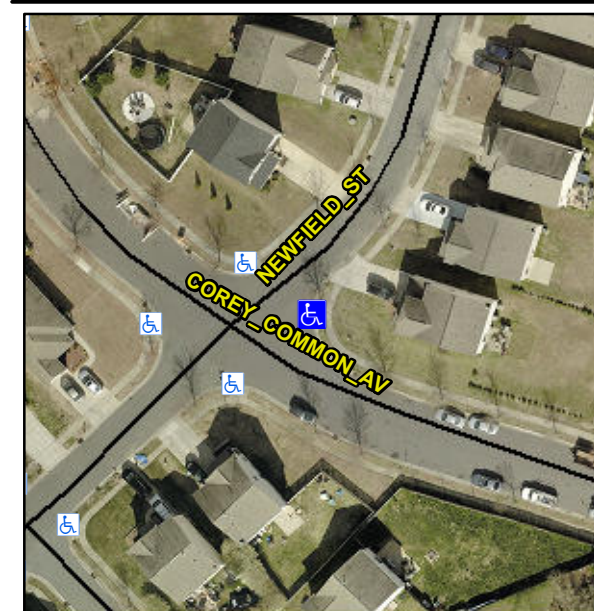
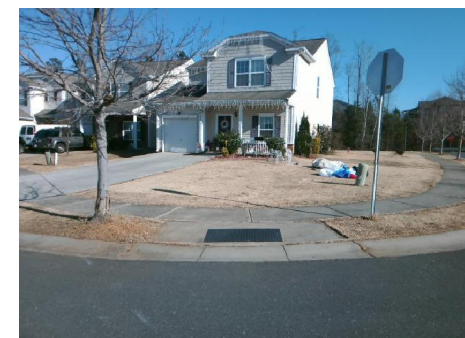
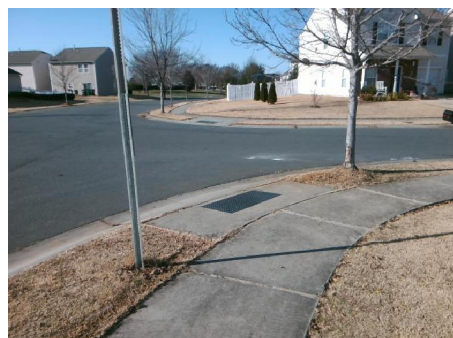
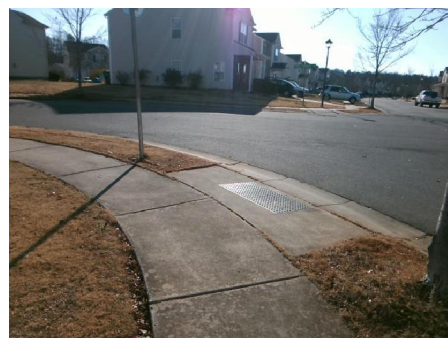
Not Found, R304.5.1

Compliance	Description	Data	Compliance	Description	Data
N/A	Ramp Length (in)	46.0	Yes	BlendTrans Slope (%)	4.0
No	Ramp Width (in)	45.0	Yes	BlendTrans XSlope (%)	1.7
N/A	Flare Type LT	N/A	N/A	Flare Type RT	N/A
N/A	Flare Slope LT (%)	N/A	N/A	Flare Slope RT (%)	N/A
N/A	Flare Traversable LT?	N/A	N/A	Flare Traversable RT?	N/A
N/A	Landing Length (in)	N/A	N/A	DWS Provided?	N/A
N/A	Landing Width (in)	N/A	N/A	DWS Contrast?	N/A
N/A	Landing Slope (%)	N/A	N/A	DWS Length (in)	N/A
N/A	Landing X Slope (%)	N/A	N/A	DWS Full Width?	N/A
N/A	Landing Curb? (Y/N)	N/A	N/A	DWS Offset (in)	N/A
N/A	Shared Landing?	N/A			
N/A	Gutter Ponding?	N/A	N/A	Gutter Slope (%)	N/A
N/A	Gutter Lip Ht (in)	N/A	N/A	Gutter X Slope (%)	N/A
N/A	Painted X Walk1?	No	N/A	Painted X Walk2?	No
	X Walk 1 Direction	To NW		X Walk 2 Direction	To SW
	X Walk 1 Width (in)	N/A		X Walk 2 Width (in)	N/A
	X Walk 1 Slope (%)	1.3		X Walk 2 Slope (%)	1.7
	X Walk 1 X Slope (%)	1.0		X Walk 2 X Slope (%)	0.7

N/A	Ramp inside XWalk1?	N/A	N/A	Ramp inside XWalk2?	N/A
	Road Slope (%)	1.0		Clear Space?	N/A
	Road X Slope (%)	1.5	N/A	Clear Space to XWalk (in)	N/A
N/A	Any Obstructions?	N/A	N/A	Storm Grate/Utility Hazard?	N/A
	Obstruction Type			Storm Grate/Utility Type	
		N/A			N/A
			Yes	Surface Condition? (G/P)	Good
			No	Curb Slope (%)	6.7

Possible Solutions:

Remove & Replace Curb Ramp With Two New Directional Ramps or Equivalent.
