Access Compliance Report Public Rights-of-Way (Curb Ramps)

Intersection ID: 15063
 Main Street:
 DUNN_AV
 Cross Street:
 ORANGE_ST
 Location:
 W

ADA ID: 732A36E1BA4B
 Ramp Type:
 PerpDiag
 Initial Pass/Fail:
 Fail
 Overall Compliance:
 No
 Severity Score:
 21.25

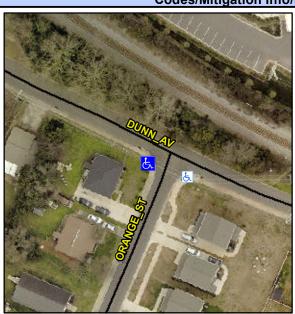
Not Found, R304.5.1, R304.5.3

Field Measurements/Component Compliance						
	Compliance Description		Data	Comp	oliance Description	Data
	N/A	Ramp Length (in)	58.0	Yes	Ramp Slope (%)	7.6
	No	Ramp Width (in)	39.0	No	Ramp XSlope (%)	6.2
	N/A	Flare Type LT	N/A	N/A	Flare Type RT	N/A
	N/A	Flare Slope LT (%)	N/A	N/A	Flare Slope RT (%)	N/A
	N/A	Flare Traversable LT?	N/A	N/A	Flare Traversable RT?	N/A
	N/A	Landing Length (in)	N/A	N/A	DWS Provided?	N/A
	N/A	Landing Width (in)	N/A	N/A	DWS Contrast?	N/A
	N/A	Landing Slope (%)	N/A	N/A	DWS Length (in)	N/A
	N/A	Landing X Slope (%)	N/A	N/A	DWS Full Width?	N/A
	N/A	Landing Curb? (Y/N)	N/A	N/A	DWS Offset (in)	N/A
	N/A	Shared Landing?	N/A			
	N/A	Gutter Ponding?	N/A	N/A	Gutter Slope (%)	N/A
	N/A	Gutter Lip Ht (in)	N/A	N/A	Gutter X Slope (%)	N/A
	N/A	Painted X Walk1?	No	N/A	Painted X Walk2?	No
		X Walk 1 Direction	To SE		X Walk 2 Direction	To NE
	N/A	X Walk 1 Width (in)	N/A	N/A	X Walk 2 Width (in)	N/A
		X Walk 1 Slope (%)	6.3		X Walk 2 Slope (%)	3.9

X Walk 1 X Slope (%)	0.8		X Walk 2 X Slope (%)	5.1
	N/A	Ramp inside XWalk1?	N/A	N/A	Ramp inside XWalk2?	N/A
		Road Slope (%)	5.0	N/A	Clear Space?	N/A
		Road X Slope (%)	6.3	N/A	Clear Space to XWalk (in)	N/A
	N/A	Any Obstructions?	N/A	N/A	Storm Grate/Utility Hazard?	N/A
		Obstruction Type			Storm Grate/Utility Type	
			N/A			N/A
				Yes	Surface Condition? (G/P)	Good
	1000

Remove & Replace Curb Ramp With Two New Directional Ramps or Equivalent.
