Access Compliance Report

Public Rights-of-Way

(Curb Ramps)

Intersection ID: 45757	Main Street: MOSS_GLEN_CT	Cross Street: GRANDEUR_RD	Location: SE
ADA ID: 7332B8800327	Ramp Type: PerpDiag	Initial Pass/Fail: Fail	Overall Compliance: No
Severity Score: 21.25			
Codes/Mitigation Info/Possible Solution		Field Measurements/Component Compliance

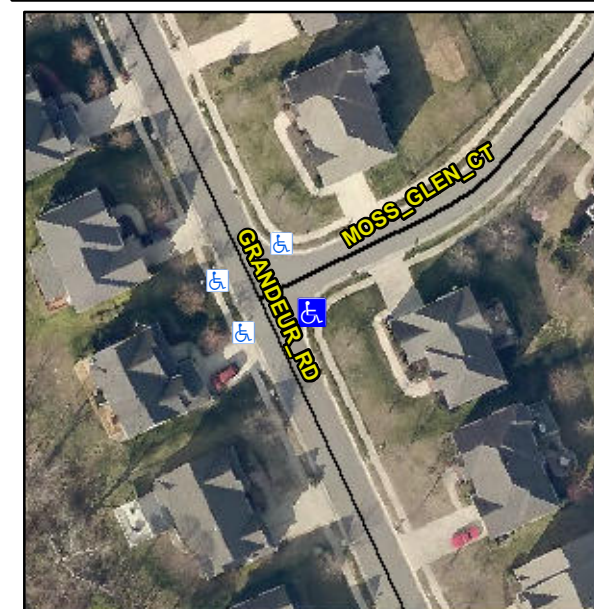
Not Found, R304.5.1, R304.2.2

Compliance	Description	Data	Compliance	Description	Data
N/A	Ramp Length (in)	49.0	No	Ramp Slope (%)	10.5
No	Ramp Width (in)	38.0	Yes	Ramp XSlope (%)	0.8
N/A	Flare Type LT	N/A	N/A	Flare Type RT	N/A
N/A	Flare Slope LT (%)	N/A	N/A	Flare Slope RT (%)	N/A
N/A	Flare Traversable LT?	N/A	N/A	Flare Traversable RT?	N/A
N/A	Landing Length (in)	N/A	N/A	DWS Provided?	N/A
N/A	Landing Width (in)	N/A	N/A	DWS Contrast?	N/A
N/A	Landing Slope (%)	N/A	N/A	DWS Length (in)	N/A
N/A	Landing X Slope (%)	N/A	N/A	DWS Full Width?	N/A
N/A	Landing Curb? (Y/N)	N/A	N/A	DWS Offset (in)	N/A
N/A	Shared Landing?	N/A			
N/A	Gutter Ponding?	N/A	N/A	Gutter Slope (%)	N/A
N/A	Gutter Lip Ht (in)	N/A	N/A	Gutter X Slope (%)	N/A
N/A	Painted X Walk1?	No	N/A	Painted X Walk2?	No
	X Walk 1 Direction	To N		X Walk 2 Direction	To W
N/A	X Walk 1 Width (in)	N/A	N/A	X Walk 2 Width (in)	N/A
	X Walk 1 Slope (%)	1.4		X Walk 2 Slope (%)	1.5
	X Walk 1 X Slope (%)	3.0		X Walk 2 X Slope (%)	1.6

N/A	Ramp inside XWalk1?	N/A	N/A	Ramp inside XWalk2?	N/A
	Road Slope (%)	2.0	N/A	Clear Space?	N/A
	Road X Slope (%)	0.3	N/A	Clear Space to XWalk (in)	N/A
N/A	Any Obstructions?	N/A	N/A	Storm Grate/Utility Hazard?	N/A
	Obstruction Type			Storm Grate/Utility Type	
		N/A			N/A
		Yes		Surface Condition? (G/P)	Good

Remove & Replace Curb Ramp With Two New Directional Ramps or Equivalent.
