# Access Compliance Report

## Public Rights-of-Way

| Intersection ID: 14359 | Main Street: N_COLONIAL_AV | Cross Street: VAIL_AV | Location: S |
| ADA ID: 7337DD12DC34 | Ramp Type: PerpDiag | Initial Pass/Fail: Fail | Overall Compliance: No |

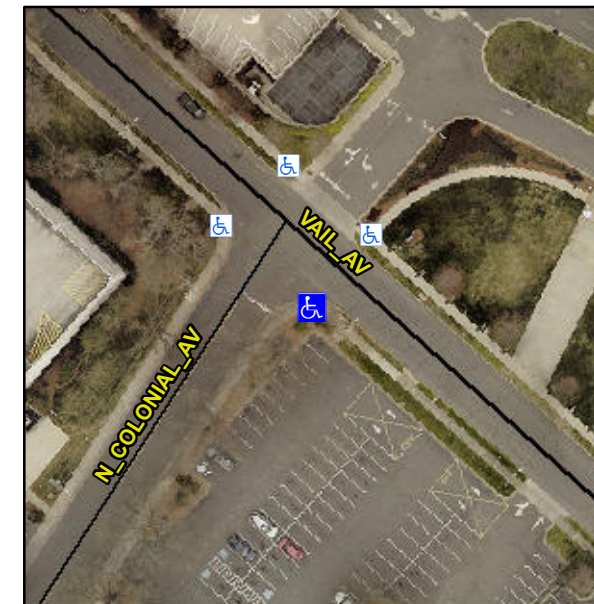
**Not Found, R304.5.3**

| Compliance | Description | Data | Compliance | Description | Data |
|---|---|---|---|---|---|
| N/A | Ramp Length (in) | 62.0 | Yes | Ramp Slope (%) | 5.5 |
| Yes | Ramp Width (in) | 58.0 | No | Ramp XSlope (%) | 5.8 |

**Remove & Replace Curb Ramp With Two New Directional Ramps or Equivalent.**

Total Cost: \$ 3200.00
