Access Compliance Report

Public Rights-of-Way

(Curb Ramps)

Intersection ID: 10649	Main Street: MARTIN_ST	Cross Street: N_SUMMIT_AV	Location:	N
ADA ID: 733AE5E8B412	Ramp Type: Perp	Initial Pass/Fail: Fail	Overall Compliance: No	Severity Score: 25
Codes/Mitigation Info/Possible Solution		Field Measurements/Component Compliance

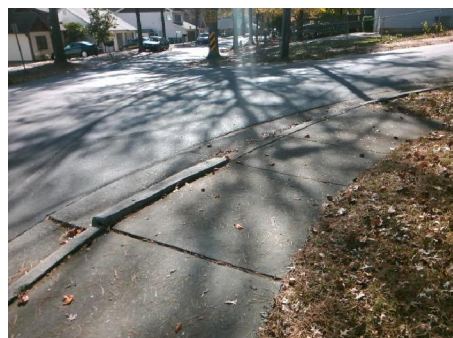
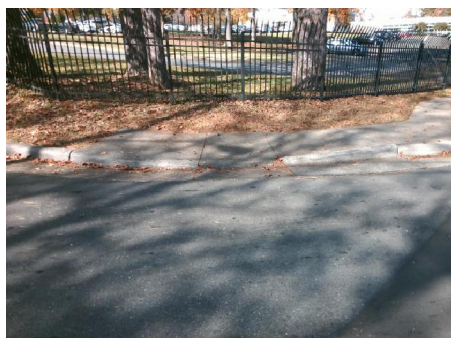
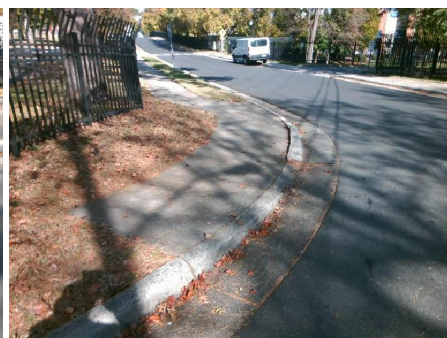
Not Found, R304.5.1, R304.5.3, R302.7

Compliance	Description	Data	Compliance	Description	Data
N/A	Ramp Length (in)	59.0	Yes	Ramp Slope (%)	7.3
No	Ramp Width (in)	41.0	No	Ramp XSlope (%)	2.9
N/A	Flare Type LT	N/A	N/A	Flare Type RT	N/A
N/A	Flare Slope LT (%)	N/A	N/A	Flare Slope RT (%)	N/A
N/A	Flare Traversable LT?	N/A	N/A	Flare Traversable RT?	N/A
N/A	Landing Length (in)	N/A	N/A	DWS Provided?	N/A
N/A	Landing Width (in)	N/A	N/A	DWS Contrast?	N/A
N/A	Landing Slope (%)	N/A	N/A	DWS Length (in)	N/A
N/A	Landing X Slope (%)	N/A	N/A	DWS Full Width?	N/A
N/A	Landing Curb? (Y/N)	N/A	N/A	DWS Offset (in)	N/A
N/A	Shared Landing?	N/A			
N/A	Gutter Ponding?	N/A	N/A	Gutter Slope (%)	N/A
N/A	Gutter Lip Ht (in)	1.5	N/A	Gutter X Slope (%)	N/A
N/A	Painted X Walk1?	No	N/A	Painted X Walk2?	N/A
	X Walk 1 Direction	To S		X Walk 2 Direction	N/A
N/A	X Walk 1 Width (in)	N/A	N/A	X Walk 2 Width (in)	N/A
	X Walk 1 Slope (%)	2.2		X Walk 2 Slope (%)	N/A
	X Walk 1 X Slope (%)	2.8		X Walk 2 X Slope (%)	N/A

N/A	Ramp inside XWalk1?	N/A	N/A	Ramp inside XWalk2?	N/A
	Road Slope (%)	N/A	N/A	Clear Space?	N/A
	Road X Slope (%)	N/A	N/A	Clear Space to XWalk (in)	N/A
N/A	Any Obstructions?	N/A	N/A	Storm Grate/Utility Hazard?	N/A
	Obstruction Type			Storm Grate/Utility Type	
		N/A			N/A
		No		Surface Condition? (G/P)	Poor

Possible Solutions:

Remove & Replace Entire Ramp.
