# Access Compliance Report

## Public Rights-of-Way

### (Curb Ramps)

Intersection ID: 19931	Main Street: CARNEGIE_BV	Cross Street: ASSEMBLY ST	Location: SE
ADA ID: 733D48ACBEFB	Ramp Type: Perp	Initial Pass/Fail: Fail	Overall Compliance: No
Severity Score: 12.5			
Codes/Mitigation Info/Possible Solution		Field Measurements/Component Compliance

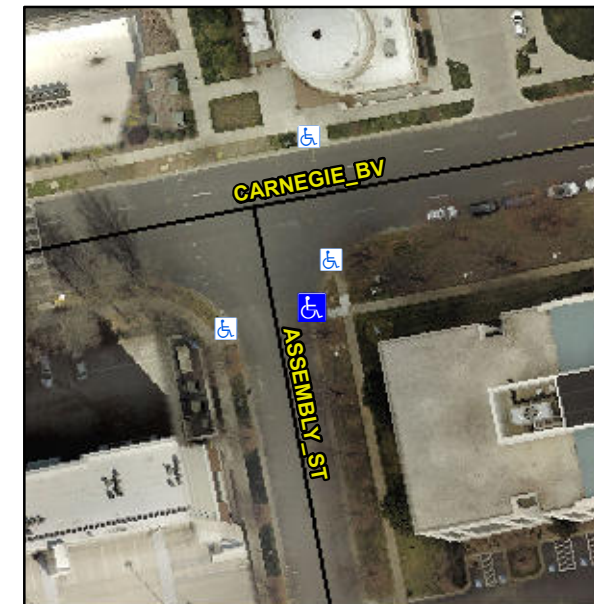
**Not Found, R304.2.2**

Compliance	Description	Data	Compliance	Description	Data
N/A	Ramp Length (in)	138.0	No	Ramp Slope (%)	9.9
Yes	Ramp Width (in)	48.0	Yes	Ramp XSlope (%)	0.7
N/A	Flare Type LT	N/A	N/A	Flare Type RT	N/A
N/A	Flare Slope LT (%)	N/A	N/A	Flare Slope RT (%)	N/A
N/A	Flare Traversable LT?	N/A	N/A	Flare Traversable RT?	N/A
N/A	Landing Length (in)	N/A	N/A	DWS Provided?	N/A
N/A	Landing Width (in)	N/A	N/A	DWS Contrast?	N/A
N/A	Landing Slope (%)	N/A	N/A	DWS Length (in)	N/A
N/A	Landing X Slope (%)	N/A	N/A	DWS Full Width?	N/A
N/A	Landing Curb? (Y/N)	N/A	N/A	DWS Offset (in)	N/A
N/A	Shared Landing?	N/A			
N/A	Gutter Ponding?	N/A	N/A	Gutter Slope (%)	N/A
N/A	Gutter Lip Ht (in)	N/A	N/A	Gutter X Slope (%)	N/A
N/A	Painted X Walk1?	No	N/A	Painted X Walk2?	N/A
	X Walk 1 Direction	To W		X Walk 2 Direction	N/A
N/A	X Walk 1 Width (in)	N/A	N/A	X Walk 2 Width (in)	N/A
	X Walk 1 Slope (%)	1.5		X Walk 2 Slope (%)	N/A
	X Walk 1 X Slope (%)	1.8		X Walk 2 X Slope (%)	N/A

Possible Solutions:

**Remove & Replace Entire Ramp.**

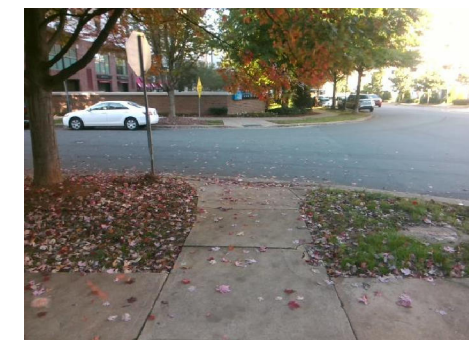
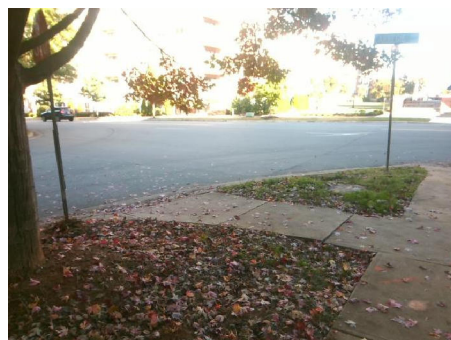
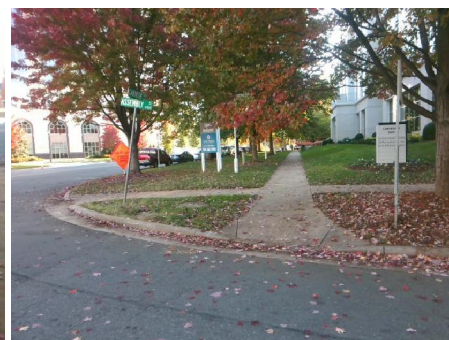
N/A	Ramp inside XWalk1?	N/A	N/A	Ramp inside XWalk2?	N/A
	Road Slope (%)	N/A	N/A	Clear Space?	N/A
	Road X Slope (%)	N/A	N/A	Clear Space to XWalk (in)	N/A
N/A	Any Obstructions?	N/A	N/A	Storm Grate/Utility Hazard?	N/A
	Obstruction Type			Storm Grate/Utility Type	
		N/A			N/A
			Yes	Surface Condition? (G/P)	Good
