# Access Compliance Report

## Public Rights-of-Way

### (Curb Ramps)

Intersection ID: 5574	Main Street: BANNER_ELK_DR	Cross Street: SUNSET_RD	Location: NE
ADA ID: 7343A25CD912	Ramp Type: BlendTrans1	Initial Pass/Fail: Fail	Overall Compliance: No
Severity Score: 8.75			
Codes/Mitigation Info/Possible Solution		Field Measurements/Component Compliance

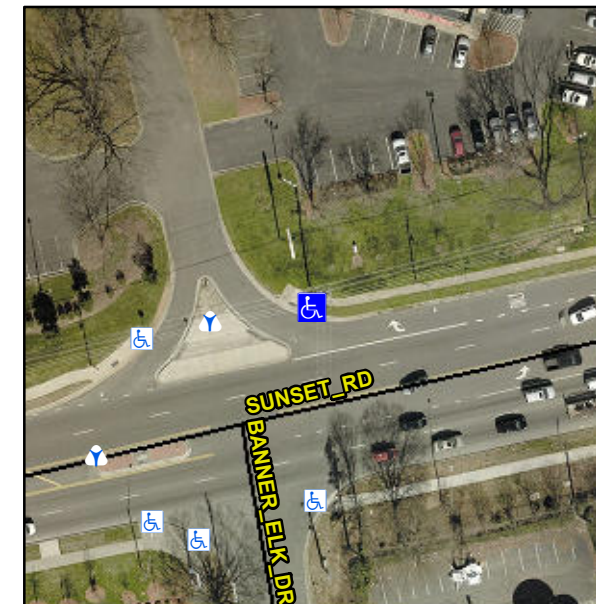
**Not Found, R304.5.1**

Compliance	Description	Data	Compliance	Description	Data
N/A	Ramp Length (in)	57.0	Yes	BlendTrans Slope (%)	2.6
No	Ramp Width (in)	47.0	Yes	BlendTrans XSlope (%)	0.9
N/A	Flare Type LT	N/A	N/A	Flare Type RT	N/A
N/A	Flare Slope LT (%)	N/A	N/A	Flare Slope RT (%)	N/A
N/A	Flare Traversable LT?	N/A	N/A	Flare Traversable RT?	N/A
N/A	Landing Length (in)	N/A	N/A	DWS Provided?	N/A
N/A	Landing Width (in)	N/A	N/A	DWS Contrast?	N/A
N/A	Landing Slope (%)	N/A	N/A	DWS Length (in)	N/A
N/A	Landing X Slope (%)	N/A	N/A	DWS Full Width?	N/A
N/A	Landing Curb? (Y/N)	N/A	N/A	DWS Offset (in)	N/A
N/A	Shared Landing?	N/A			
N/A	Gutter Ponding?	N/A	N/A	Gutter Slope (%)	N/A
N/A	Gutter Lip Ht (in)	N/A	N/A	Gutter X Slope (%)	N/A
N/A	Painted X Walk1?	No	N/A	Painted X Walk2?	N/A
	X Walk 1 Direction	To W		X Walk 2 Direction	N/A
	X Walk 1 Width (in)	N/A		X Walk 2 Width (in)	N/A
	X Walk 1 Slope (%)	1.9		X Walk 2 Slope (%)	N/A
	X Walk 1 X Slope (%)	4.1		X Walk 2 X Slope (%)	N/A

N/A	Ramp inside XWalk1?	N/A	N/A	Ramp inside XWalk2?	N/A
	Road Slope (%)	4.1		Clear Space?	N/A
	Road X Slope (%)	1.9	N/A	Clear Space to XWalk (in)	N/A
N/A	Any Obstructions?	N/A	N/A	Storm Grate/Utility Hazard?	N/A
	Obstruction Type			Storm Grate/Utility Type	
		N/A			N/A
			Yes	Surface Condition? (G/P)	Good
			No	Curb Slope (%)	6.6

**Remove & Replace Curb Ramp With Two New Directional Ramps or Equivalent.**

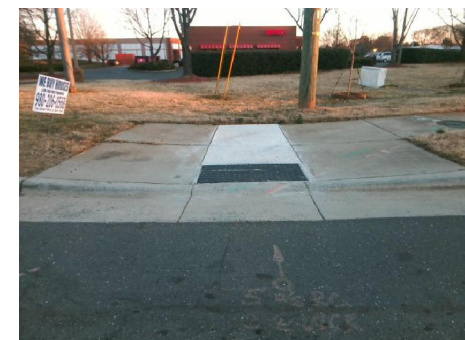
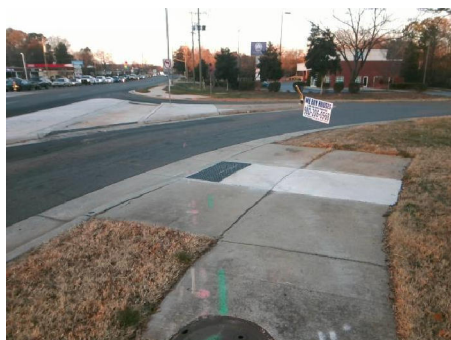
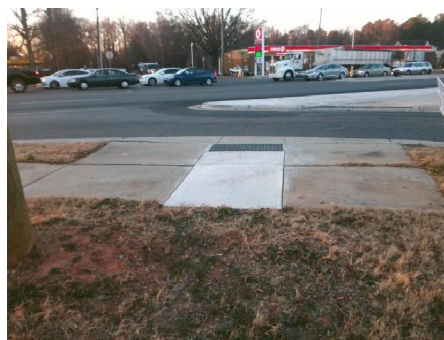
Street 1 Name	SUNSET RD
Stop Condition-Street 1	None
Street 2 Name	N/A
Stop Condition-Street 2	N/A
