# Access Compliance Report

## Public Rights-of-Way

### (Curb Ramps)

Intersection ID: N/A	Main Street: MORABLIN_DR	Cross Street: DURANT_BV	Location: SW
ADA ID: 734C214CE69B	Ramp Type: PerpDiag	Initial Pass/Fail: Fail	Overall Compliance: No
Codes/Mitigation Info/Possible Solution		Field Measurements/Component Compliance

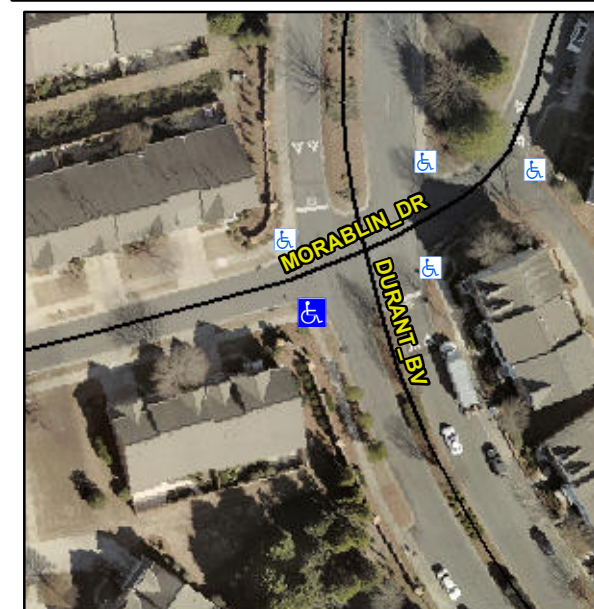
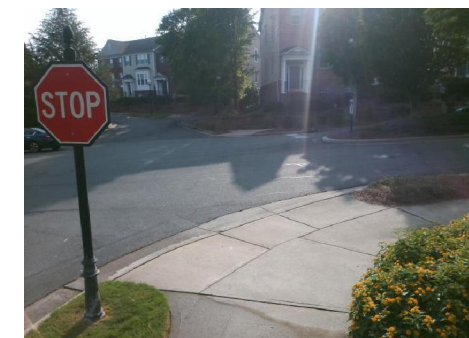
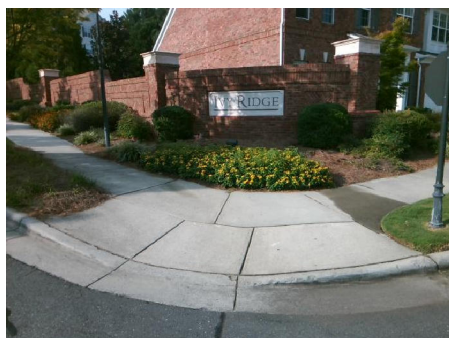
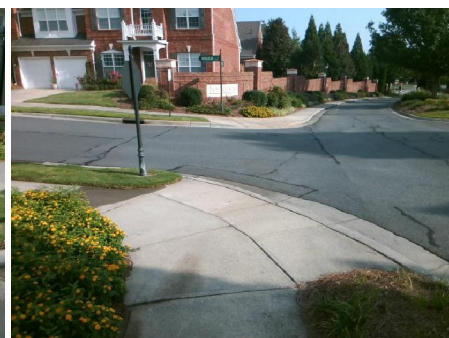
**Not Found, R304.5.1, R304.2.2, R304.5.3**

Compliance	Description	Data	Compliance	Description	Data
N/A	Ramp Length (in)	49.0	No	Ramp Slope (%)	9.6
No	Ramp Width (in)	40.0	No	Ramp XSlope (%)	5.3
N/A	Flare Type LT	N/A	N/A	Flare Type RT	N/A
N/A	Flare Slope LT (%)	N/A	N/A	Flare Slope RT (%)	N/A
N/A	Flare Traversable LT?	N/A	N/A	Flare Traversable RT?	N/A
N/A	Landing Length (in)	N/A	N/A	DWS Provided?	N/A
N/A	Landing Width (in)	N/A	N/A	DWS Contrast?	N/A
N/A	Landing Slope (%)	N/A	N/A	DWS Length (in)	N/A
N/A	Landing X Slope (%)	N/A	N/A	DWS Full Width?	N/A
N/A	Landing Curb? (Y/N)	N/A	N/A	DWS Offset (in)	N/A
N/A	Shared Landing?	N/A			
N/A	Gutter Ponding?	N/A	N/A	Gutter Slope (%)	N/A
N/A	Gutter Lip Ht (in)	N/A	N/A	Gutter X Slope (%)	N/A
N/A	Painted X Walk1?	No	N/A	Painted X Walk2?	No
	X Walk 1 Direction	To E		X Walk 2 Direction	To N
N/A	X Walk 1 Width (in)	N/A	N/A	X Walk 2 Width (in)	N/A
	X Walk 1 Slope (%)	2.8		X Walk 2 Slope (%)	2.1
	X Walk 1 X Slope (%)	5.6		X Walk 2 X Slope (%)	2.9

N/A	Ramp inside XWalk1?	N/A	N/A	Ramp inside XWalk2?	N/A
	Road Slope (%)	5.4	N/A	Clear Space?	N/A
	Road X Slope (%)	1.8	N/A	Clear Space to XWalk (in)	N/A
N/A	Any Obstructions?	N/A	N/A	Storm Grate/Utility Hazard?	N/A
	Obstruction Type			Storm Grate/Utility Type	
		N/A			N/A
			Yes	Surface Condition? (G/P)	Good

**Remove & Replace Curb Ramp With Two New Directional Ramps or Equivalent.**

Total Cost: \$ 3200.00
