Access Compliance Report

Public Rights-of-Way

(Curb Ramps)

Intersection ID: 9648	Main Street: TIMBERBROOK_DR	Cross Street: TUCKASEEGEE_RD	Location: SW
ADA ID: 734C5C5F1E4A	Ramp Type: Directional1	Initial Pass/Fail: Fail	Overall Compliance: No
		Severity Score: 1.25

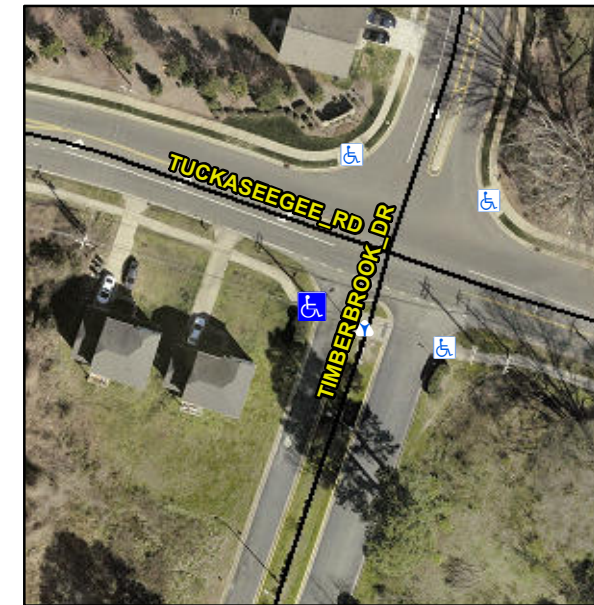
R304.5.3

Compliance	Description	Data	Compliance	Description	Data
N/A	Ramp Length (in)	62.0	N/A	Grade Break?	N/A
Yes	Ramp Width (in)	68.5	N/A	Grade Break Slope (%)	0.0
Yes	Ramp Slope (%)	6.3	N/A	Grade Break XSlope (%)	0.0
No	Ramp XSlope (%)	2.1			
N/A	Flare Type LT	N/A	N/A	Flare Type RT	N/A
N/A	Flare Slope LT (%)	N/A	N/A	Flare Slope RT (%)	0.0
N/A	Flare Traversable LT?	N/A	N/A	Flare Traversable RT?	N/A
N/A	Landing Length (in)	0.0	N/A	DWS Provided?	N/A
N/A	Landing Width (in)	0.0	N/A	DWS Contrast?	N/A
N/A	Landing Slope (%)	0.0	N/A	DWS Length (in)	N/A
N/A	Landing X Slope (%)	0.0	N/A	DWS Full Width?	N/A
N/A	Landing Curb? (Y/N)	N/A	N/A	DWS Offset LT (in)	N/A
N/A	Shared Landing?	N/A	N/A	DWS Offset RT (in)	N/A
N/A	Gutter Ponding?	0.0	N/A	Gutter Slope (%)	N/A
N/A	Gutter Lip Ht (in)	0.0	N/A	Gutter X Slope (%)	N/A
N/A	Painted X Walk1?	No		Road Slope (%)	5.3
	X Walk 1 Direction	To E		Road X Slope (%)	3.2
	X Walk 1 Width (in)	N/A		Clear Space?	N/A

X Walk 1 Slope (%)	5.3	N/A	Clear Space to XWalk (in)	N/A
	X Walk 1 X Slope (%)	3.2	N/A	Storm Grate/Utility Hazard?	N/A
N/A	Ramp inside XWalk1?	N/A		Storm Grate/Utility Type	
N/A	Any Obstructions?	N/A			N/A
	Obstruction Type		Yes	Surface Condition? (G/P)	Good
			N/A	Curb Slope (%)	6.7

Remove & Replace Entire Ramp.

Total Cost: \$ 1600.00
